Access Compliance Report

Public Rights-of-Way

(Curb Ramps)

Intersection ID: 12401	Main Street: MIDWOOD_PL	Cross Street: TIPPAH_AV	Location: NE
ADA ID: 866C1A76CAFD	Ramp Type: Perp	Initial Pass/Fail: Fail	Overall Compliance: No
Severity Score: 13.75			
Codes/Mitigation Info/Possible Solution		Field Measurements/Component Compliance

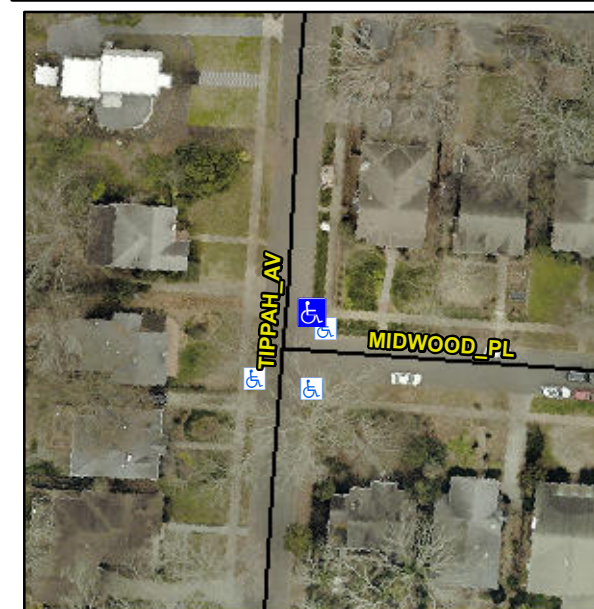
Not Found, R304.2.2, R304.5.3

Compliance	Description	Data	Compliance	Description	Data
N/A	Ramp Length (in)	65.0	No	Ramp Slope (%)	9.3
Yes	Ramp Width (in)	48.0	No	Ramp XSlope (%)	4.5
N/A	Flare Type LT	N/A	N/A	Flare Type RT	N/A
N/A	Flare Slope LT (%)	N/A	N/A	Flare Slope RT (%)	N/A
N/A	Flare Traversable LT?	N/A	N/A	Flare Traversable RT?	N/A
N/A	Landing Length (in)	N/A	N/A	DWS Provided?	N/A
N/A	Landing Width (in)	N/A	N/A	DWS Contrast?	N/A
N/A	Landing Slope (%)	N/A	N/A	DWS Length (in)	N/A
N/A	Landing X Slope (%)	N/A	N/A	DWS Full Width?	N/A
N/A	Landing Curb? (Y/N)	N/A	N/A	DWS Offset (in)	N/A
N/A	Shared Landing?	N/A			
N/A	Gutter Ponding?	N/A	N/A	Gutter Slope (%)	N/A
N/A	Gutter Lip Ht (in)	1.0	N/A	Gutter X Slope (%)	N/A
N/A	Painted X Walk1?	No	N/A	Painted X Walk2?	N/A
	X Walk 1 Direction	To W		X Walk 2 Direction	N/A
N/A	X Walk 1 Width (in)	N/A	N/A	X Walk 2 Width (in)	N/A
	X Walk 1 Slope (%)	1.6		X Walk 2 Slope (%)	N/A
	X Walk 1 X Slope (%)	3.6		X Walk 2 X Slope (%)	N/A

N/A	Ramp inside XWalk1?	N/A	N/A	Ramp inside XWalk2?	N/A
	Road Slope (%)	N/A	N/A	Clear Space?	N/A
	Road X Slope (%)	N/A	N/A	Clear Space to XWalk (in)	N/A
N/A	Any Obstructions?	N/A	N/A	Storm Grate/Utility Hazard?	N/A
	Obstruction Type			Storm Grate/Utility Type	
		N/A			N/A
		Yes		Surface Condition? (G/P)	Good

Possible Solutions:

Remove & Replace Entire Ramp.
