Access Compliance Report

Public Rights-of-Way

(Curb Ramps)

Intersection ID: 14620	Main Street: EUCLID_AV	Cross Street: MCDONALD_AV	Location: W
ADA ID: 8675074F3E34	Ramp Type: PerpDiag	Initial Pass/Fail: Fail	Overall Compliance: No
Severity Score: 22.5			
Codes/Mitigation Info/Possible Solution		Field Measurements/Component Compliance

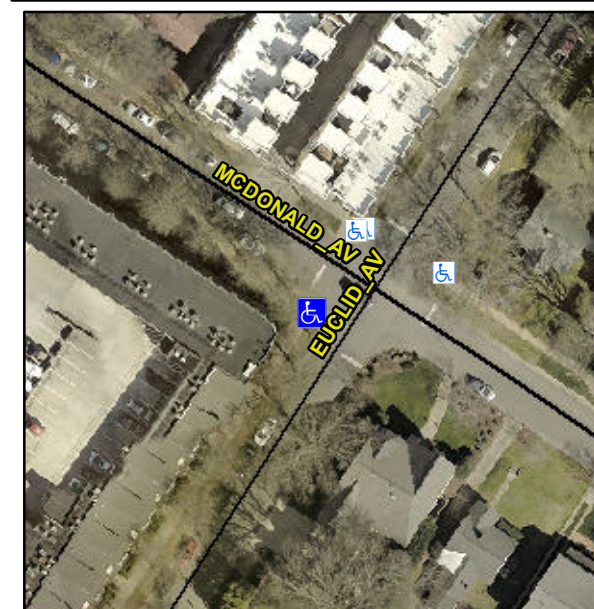
Compliance	Description	Data	Compliance	Description	Data
N/A	Ramp Length (in)	96.0	No	Ramp Slope (%)	9.1
No	Ramp Width (in)	47.0	No	Ramp XSlope (%)	2.1
N/A	Flare Type LT	N/A	N/A	Flare Type RT	N/A
N/A	Flare Slope LT (%)	N/A	N/A	Flare Slope RT (%)	N/A
N/A	Flare Traversable LT?	N/A	N/A	Flare Traversable RT?	N/A
N/A	Landing Length (in)	N/A	N/A	DWS Provided?	N/A
N/A	Landing Width (in)	N/A	N/A	DWS Contrast?	N/A
N/A	Landing Slope (%)	N/A	N/A	DWS Length (in)	N/A
N/A	Landing X Slope (%)	N/A	N/A	DWS Full Width?	N/A
N/A	Landing Curb? (Y/N)	N/A	N/A	DWS Offset (in)	N/A
N/A	Shared Landing?	N/A			
N/A	Gutter Ponding?	N/A	N/A	Gutter Slope (%)	N/A
N/A	Gutter Lip Ht (in)	N/A	N/A	Gutter X Slope (%)	N/A
N/A	Painted X Walk1?	No	N/A	Painted X Walk2?	No
	X Walk 1 Direction	To SE		X Walk 2 Direction	To NE
N/A	X Walk 1 Width (in)	N/A	N/A	X Walk 2 Width (in)	N/A
	X Walk 1 Slope (%)	2.5		X Walk 2 Slope (%)	0.8
	X Walk 1 X Slope (%)	0.3		X Walk 2 X Slope (%)	2.3

N/A	Ramp inside XWalk1?	N/A	N/A	Ramp inside XWalk2?	N/A
	Road Slope (%)	0.1	N/A	Clear Space?	N/A
	Road X Slope (%)	1.5	N/A	Clear Space to XWalk (in)	N/A
N/A	Any Obstructions?	N/A	N/A	Storm Grate/Utility Hazard?	N/A
	Obstruction Type			Storm Grate/Utility Type	
		N/A			N/A
			Yes	Surface Condition? (G/P)	Good

Possible Solutions:

Remove & Replace Curb Ramp With Two New Directional Ramps or Equivalent.

R304.5.1, R304.2.2, R304.5.3
