# Access Compliance Report

## Public Rights-of-Way

Intersection ID: 49138	Main Street: CLARKE RIDGE CT	Cross Street: AMBER LEIGH WAY DR	Location: SE
ADA ID: 86836A12DB7E	Ramp Type: PerpDiag	Initial Pass/Fail: Fail	Overall Compliance: No
Codes/Mitigation Info/Possible Solution			Severity Score: 10
			Field Measurements/Component Compliance

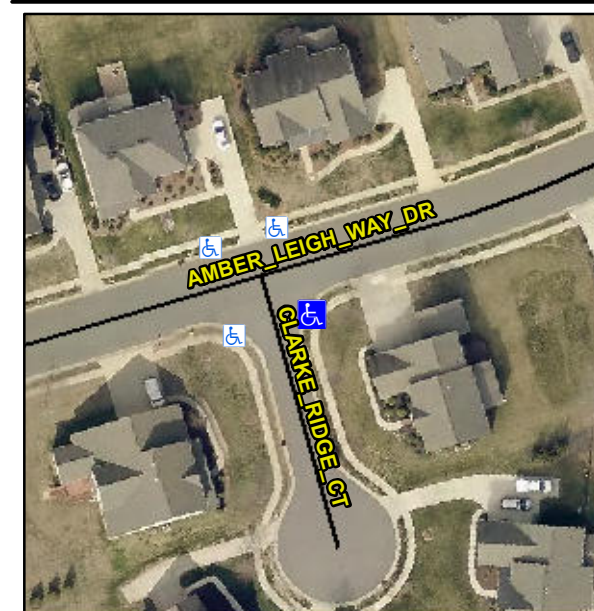
**Not Found, R304.5.1, R304.5.3**

Compliance	Description	Data	Compliance	Description	Data
N/A	Ramp Length (in)	48.0	Yes	Ramp Slope (%)	6.9
No	Ramp Width (in)	47.5	No	Ramp XSlope (%)	3.6
N/A	Flare Type LT	N/A	N/A	Flare Type RT	N/A
N/A	Flare Slope LT (%)	N/A	N/A	Flare Slope RT (%)	N/A
N/A	Flare Traversable LT?	N/A	N/A	Flare Traversable RT?	N/A
N/A	Landing Length (in)	N/A	N/A	DWS Provided?	N/A
N/A	Landing Width (in)	N/A	N/A	DWS Contrast?	N/A
N/A	Landing Slope (%)	N/A	N/A	DWS Length (in)	N/A
N/A	Landing X Slope (%)	N/A	N/A	DWS Full Width?	N/A
N/A	Landing Curb? (Y/N)	N/A	N/A	DWS Offset (in)	N/A
N/A	Shared Landing?	N/A			
N/A	Gutter Ponding?	N/A	N/A	Gutter Slope (%)	N/A
N/A	Gutter Lip Ht (in)	N/A	N/A	Gutter X Slope (%)	N/A
N/A	Painted X Walk1?	No	N/A	Painted X Walk2?	No
	X Walk 1 Direction	To N		X Walk 2 Direction	To W
N/A	X Walk 1 Width (in)	N/A	N/A	X Walk 2 Width (in)	N/A
	X Walk 1 Slope (%)	6.9		X Walk 2 Slope (%)	1.2
	X Walk 1 X Slope (%)	3.1		X Walk 2 X Slope (%)	6.3

N/A	Ramp inside XWalk1?	N/A	N/A	Ramp inside XWalk2?	N/A
	Road Slope (%)	4.9	N/A	Clear Space?	N/A
	Road X Slope (%)	4.0	N/A	Clear Space to XWalk (in)	N/A
N/A	Any Obstructions?	N/A	N/A	Storm Grate/Utility Hazard?	N/A
	Obstruction Type			Storm Grate/Utility Type	
		N/A			N/A
			Yes	Surface Condition? (G/P)	Good

**Remove & Replace Curb Ramp With Two New Directional Ramps or Equivalent.**
