Access Compliance Report

Public Rights-of-Way

(Curb Ramps)

| Intersection ID: 13520 | Main Street: E_7TH_ST | Cross Street: BEAUMONT_AV | Location: N |

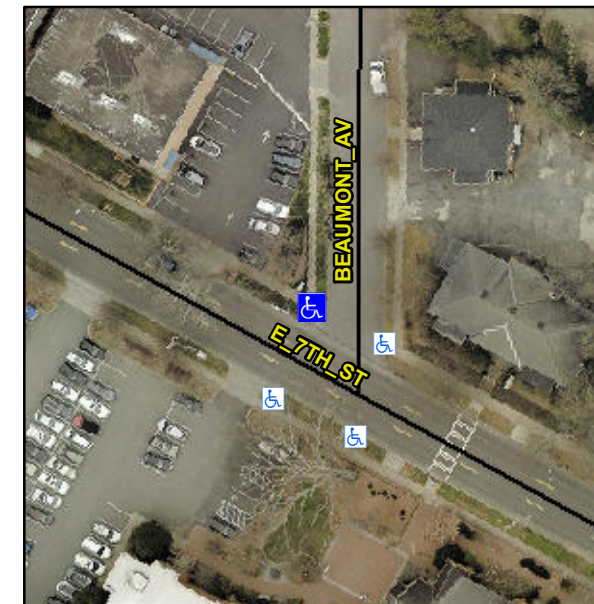
| ADA ID: 869E756E3D59 | Ramp Type: PerpDiag | Initial Pass/Fail: Fail | Overall Compliance: No |

| Compliance | Description | Data | Compliance | Description | Data |
|---|---|---|---|---|---|
| N/A | Ramp Length (in) | 87.0 | No | Ramp Slope (%) | 8.8 |
| Yes | Ramp Width (in) | 95.0 | No | Ramp XSlope (%) | 4.2 |

Remove & Replace Curb Ramp With Two New Directional Ramps or Equivalent.

R304.2.2, R304.5.3

Total Cost: \$ 3200.00
