Access Compliance Report

Public Rights-of-Way

(Curb Ramps)

Intersection ID: 46317	Main Street: MAGNASCO_LN	Cross Street: BREWER_DR	Location:	E
ADA ID: 86A7B9C6CCBA	Ramp Type: Perp	Initial Pass/Fail: Fail	Overall Compliance: No	Severity Score: 8.75
Codes/Mitigation Info/Possible Solution		Field Measurements/Component Compliance

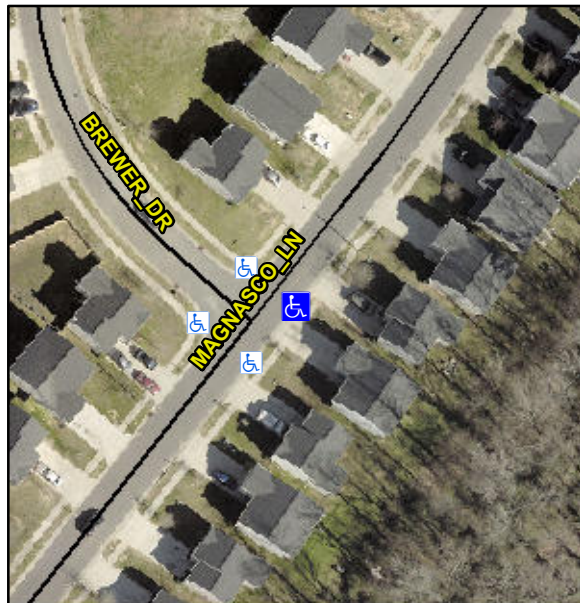
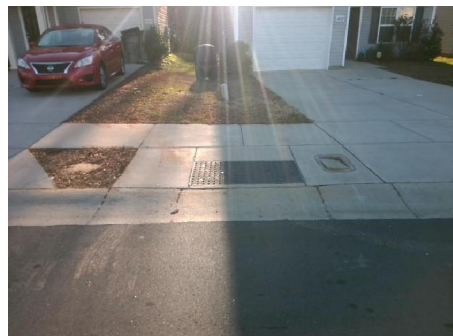
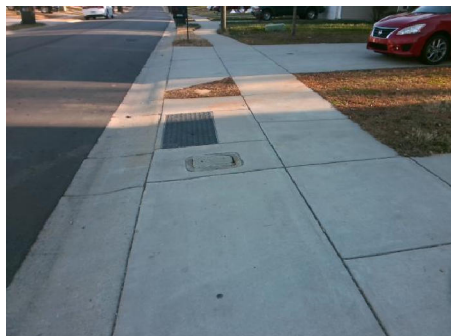
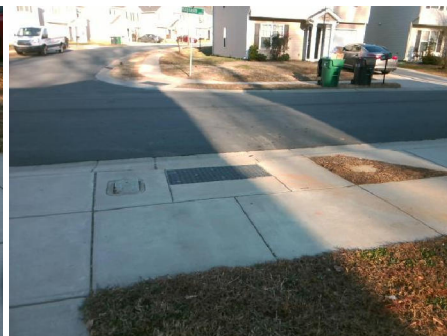
Not Found, R304.5.1

Compliance	Description	Data	Compliance	Description	Data
N/A	Ramp Length (in)	47.5	Yes	Ramp Slope (%)	5.5
No	Ramp Width (in)	47.5	Yes	Ramp XSlope (%)	0.5
N/A	Flare Type LT	N/A	N/A	Flare Type RT	N/A
N/A	Flare Slope LT (%)	N/A	N/A	Flare Slope RT (%)	N/A
N/A	Flare Traversable LT?	N/A	N/A	Flare Traversable RT?	N/A
N/A	Landing Length (in)	N/A	N/A	DWS Provided?	N/A
N/A	Landing Width (in)	N/A	N/A	DWS Contrast?	N/A
N/A	Landing Slope (%)	N/A	N/A	DWS Length (in)	N/A
N/A	Landing X Slope (%)	N/A	N/A	DWS Full Width?	N/A
N/A	Landing Curb? (Y/N)	N/A	N/A	DWS Offset (in)	N/A
N/A	Shared Landing?	N/A			
N/A	Gutter Ponding?	N/A	N/A	Gutter Slope (%)	N/A
N/A	Gutter Lip Ht (in)	N/A	N/A	Gutter X Slope (%)	N/A
N/A	Painted X Walk1?	No	N/A	Painted X Walk2?	N/A
	X Walk 1 Direction	To NW		X Walk 2 Direction	N/A
N/A	X Walk 1 Width (in)	N/A	N/A	X Walk 2 Width (in)	N/A
	X Walk 1 Slope (%)	5.5		X Walk 2 Slope (%)	N/A
	X Walk 1 X Slope (%)	0.8		X Walk 2 X Slope (%)	N/A

N/A	Ramp inside XWalk1?	N/A	N/A	Ramp inside XWalk2?	N/A
	Road Slope (%)	N/A	N/A	Clear Space?	N/A
	Road X Slope (%)	N/A	N/A	Clear Space to XWalk (in)	N/A
N/A	Any Obstructions?	N/A	N/A	Storm Grate/Utility Hazard?	N/A
	Obstruction Type			Storm Grate/Utility Type	
		N/A			N/A
			Yes	Surface Condition? (G/P)	Good

Remove & Replace Entire Ramp.
