Access Compliance Report

Public Rights-of-Way

(Curb Ramps)

Intersection ID: 10023821	Main Street: COLONY_RD	Cross Street: N/A	Location: W
ADA ID: 86B3645086C0	Ramp Type: Perp	Initial Pass/Fail: Fail	Overall Compliance: No
			Severity Score: 26.25

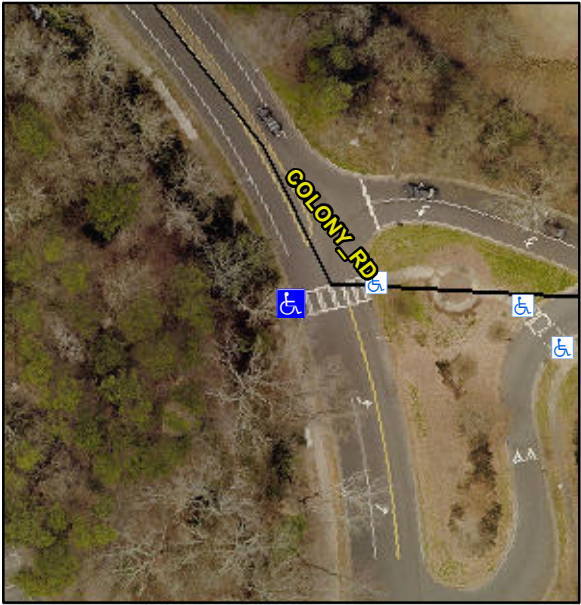
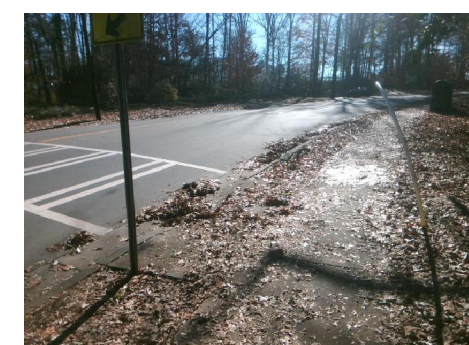
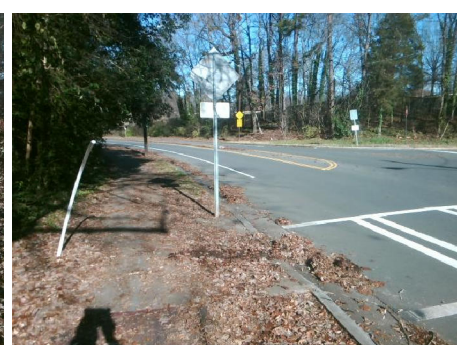
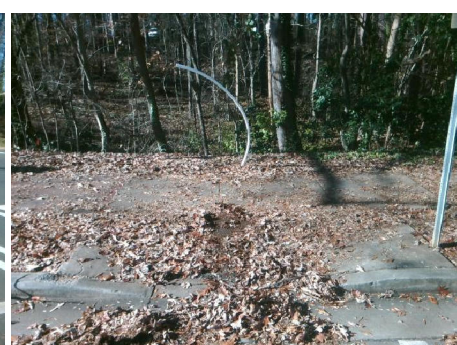
Possible Solutions:		Compliance	Description	Data
	Remove & Replace Entire Ramp.		No	Ramp Length (in)	53.0
			Yes	Ramp Width (in)	48.0
			N/A	Flare Type LT	N/A
			N/A	Flare Slope LT (%)	N/A
			N/A	Flare Traversable LT?	N/A
			N/A	Landing Length (in)	N/A
			N/A	Landing Width (in)	N/A
			N/A	Landing Slope (%)	N/A
			N/A	Landing X Slope (%)	N/A
<p>Surveyor Notes:</p> <p>N/A</p> <p>PROW/ADA:</p> <p>R304.2.2</p>			N/A	Flare Type RT	N/A
			N/A	Flare Slope RT (%)	N/A
			N/A	Flare Traversable RT?	N/A
			N/A	DWS Provided?	N/A
			N/A	DWS Contrast?	N/A
			N/A	DWS Length (in)	N/A
			N/A	DWS Full Width?	N/A
			N/A	DWS Offset (in)	N/A
			N/A	Shared Landing?	N/A
			N/A	Gutter Ponding?	N/A
			N/A	Gutter Lip Ht (in)	N/A
			N/A	Painted X Walk1?	Yes
				X Walk 1 Direction	To E
			N/A	X Walk 1 Width (in)	134.0
				X Walk 1 Slope (%)	7.6
				X Walk 1 X Slope (%)	4.5

N/A	Ramp inside XWalk1?	Yes
			N/A	Road Slope (%)	N/A
			N/A	Road X Slope (%)	N/A
			N/A	Any Obstructions?	N/A
Total Cost:		\$ 1850.00		Obstruction Type	
			N/A	Clear Space?	N/A
			N/A	Clear Space to XWalk (in)	N/A
			N/A	Storm Grate/Utility Hazard?	N/A
				Storm Grate/Utility Type	
			N/A		N/A
			Yes	Surface Condition? (G/P)	Good
