Access Compliance Report

Public Rights-of-Way

(Curb Ramps)

Intersection ID: 24214	Main Street: HENSEY'S_WY	Cross Street: BEVERLY_CREST_BV	Location: E
ADA ID: 86CA7F9BE33B	Ramp Type: Perp	Initial Pass/Fail: Fail	Overall Compliance: No
Codes/Mitigation Info/Possible Solution		Field Measurements/Component Compliance	
Severity Score: 13.75

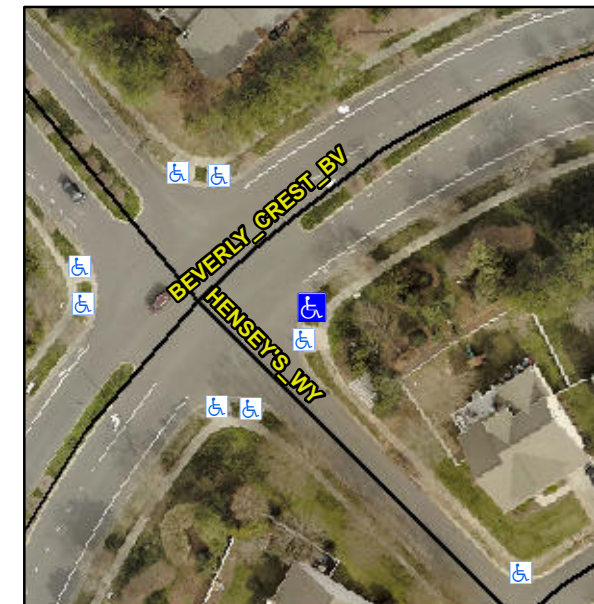
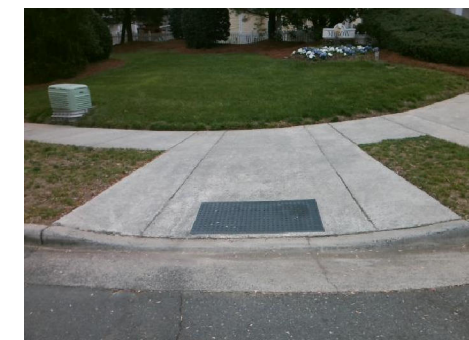
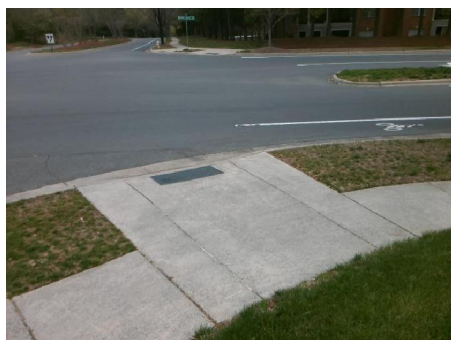
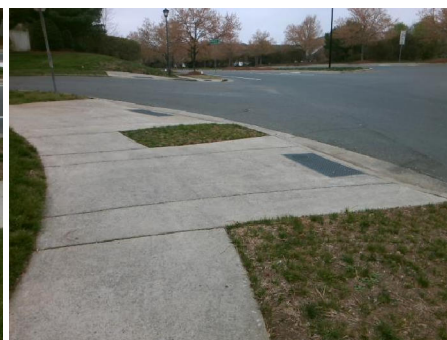
Not Found, R304.2.2, R304.5.3

Compliance	Description	Data	Compliance	Description	Data
N/A	Ramp Length (in)	100.0	No	Ramp Slope (%)	9.2
Yes	Ramp Width (in)	68.0	No	Ramp XSlope (%)	3.5
N/A	Flare Type LT	N/A	N/A	Flare Type RT	N/A
N/A	Flare Slope LT (%)	N/A	N/A	Flare Slope RT (%)	N/A
N/A	Flare Traversable LT?	N/A	N/A	Flare Traversable RT?	N/A
N/A	Landing Length (in)	N/A	N/A	DWS Provided?	N/A
N/A	Landing Width (in)	N/A	N/A	DWS Contrast?	N/A
N/A	Landing Slope (%)	N/A	N/A	DWS Length (in)	N/A
N/A	Landing X Slope (%)	N/A	N/A	DWS Full Width?	N/A
N/A	Landing Curb? (Y/N)	N/A	N/A	DWS Offset (in)	N/A
N/A	Shared Landing?	N/A			
N/A	Gutter Ponding?	N/A	N/A	Gutter Slope (%)	N/A
N/A	Gutter Lip Ht (in)	N/A	N/A	Gutter X Slope (%)	N/A
N/A	Painted X Walk1?	No	N/A	Painted X Walk2?	N/A
	X Walk 1 Direction	To N		X Walk 2 Direction	N/A
N/A	X Walk 1 Width (in)	N/A	N/A	X Walk 2 Width (in)	N/A
	X Walk 1 Slope (%)	3.5		X Walk 2 Slope (%)	N/A
	X Walk 1 X Slope (%)	1.5		X Walk 2 X Slope (%)	N/A

N/A	Ramp inside XWalk1?	N/A	N/A	Ramp inside XWalk2?	N/A
	Road Slope (%)	N/A	N/A	Clear Space?	N/A
	Road X Slope (%)	N/A	N/A	Clear Space to XWalk (in)	N/A
N/A	Any Obstructions?	N/A	N/A	Storm Grate/Utility Hazard?	N/A
	Obstruction Type			Storm Grate/Utility Type	
		N/A			N/A
			Yes	Surface Condition? (G/P)	Good

Remove & Replace Entire Ramp.
