Access Compliance Report

Public Rights-of-Way

(Curb Ramps)

Intersection ID: 11306	Main Street: W_9TH_ST	Cross Street: N_SMITH_ST	Location:	N
ADA ID: 86D20985E8D2	Ramp Type: PerpDiag	Initial Pass/Fail: Fail	Overall Compliance: No	Severity Score: 8.75
Codes/Mitigation Info/Possible Solution		Field Measurements/Component Compliance

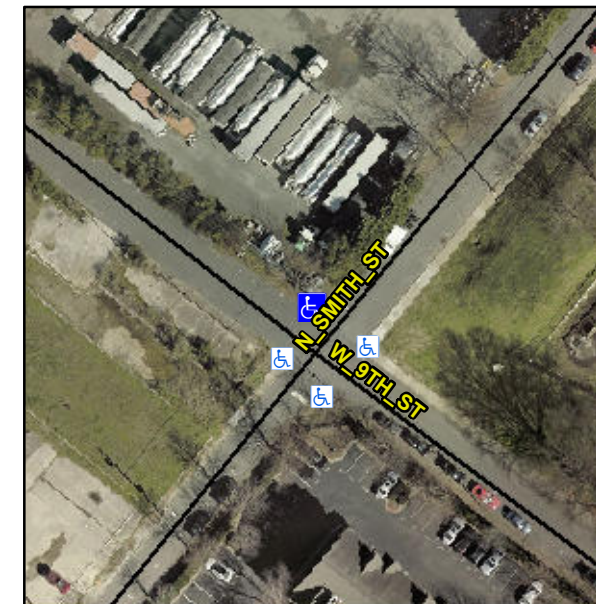
Compliance	Description	Data	Compliance	Description	Data
N/A	Ramp Length (in)	49.0	Yes	Ramp Slope (%)	5.4
No	Ramp Width (in)	40.0	Yes	Ramp XSlope (%)	1.5
N/A	Flare Type LT	N/A	N/A	Flare Type RT	N/A
N/A	Flare Slope LT (%)	N/A	N/A	Flare Slope RT (%)	N/A
N/A	Flare Traversable LT?	N/A	N/A	Flare Traversable RT?	N/A
N/A	Landing Length (in)	N/A	N/A	DWS Provided?	N/A
N/A	Landing Width (in)	N/A	N/A	DWS Contrast?	N/A
N/A	Landing Slope (%)	N/A	N/A	DWS Length (in)	N/A
N/A	Landing X Slope (%)	N/A	N/A	DWS Full Width?	N/A
N/A	Landing Curb? (Y/N)	N/A	N/A	DWS Offset (in)	N/A
N/A	Shared Landing?	N/A			
N/A	Gutter Ponding?	Yes	N/A	Gutter Slope (%)	N/A
N/A	Gutter Lip Ht (in)	N/A	N/A	Gutter X Slope (%)	N/A
N/A	Painted X Walk1?	No	N/A	Painted X Walk2?	No
	X Walk 1 Direction	To SW		X Walk 2 Direction	To SE
N/A	X Walk 1 Width (in)	N/A	N/A	X Walk 2 Width (in)	N/A
	X Walk 1 Slope (%)	4.4		X Walk 2 Slope (%)	5.5
	X Walk 1 X Slope (%)	1.0		X Walk 2 X Slope (%)	2.1

N/A	Ramp inside XWalk1?	N/A	N/A	Ramp inside XWalk2?	N/A
	Road Slope (%)	1.9	N/A	Clear Space?	N/A
	Road X Slope (%)	7.0	N/A	Clear Space to XWalk (in)	N/A
N/A	Any Obstructions?	N/A	N/A	Storm Grate/Utility Hazard?	N/A
	Obstruction Type			Storm Grate/Utility Type	
		N/A			N/A
		Yes		Surface Condition? (G/P)	Good

Possible Solutions:

Remove & Replace Curb Ramp With Two New Directional Ramps or Equivalent.

Not Found, R304.5.1

Total Cost: \$ 3200.00
