Access Compliance Report

Public Rights-of-Way

(Curb Ramps)

Intersection ID: 49931	Main Street: WOBURN_RD	Cross Street: ASHBOURNE_HALL_RD	Location: NW
ADA ID: 86D5E16EE96E	Ramp Type: Perp	Initial Pass/Fail: Fail	Overall Compliance: No
Severity Score: 10			
Codes/Mitigation Info/Possible Solution		Field Measurements/Component Compliance

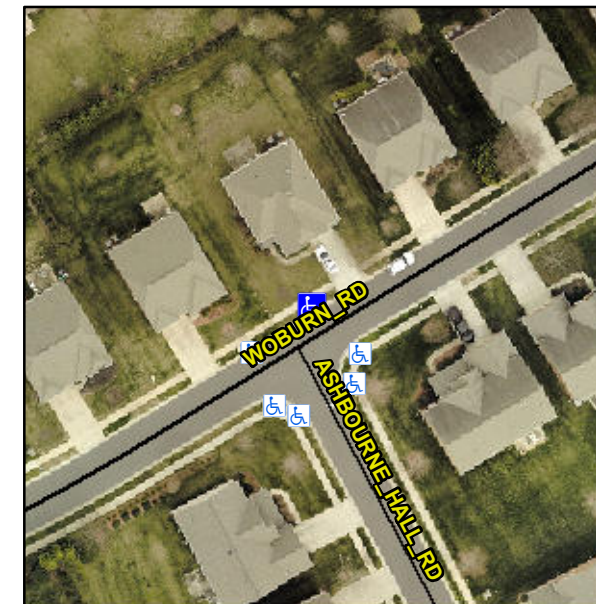
Not Found, R304.5.1

Compliance	Description	Data	Compliance	Description	Data
N/A	Ramp Length (in)	47.0	Yes	Ramp Slope (%)	6.2
No	Ramp Width (in)	47.0	Yes	Ramp XSlope (%)	2.5
N/A	Flare Type LT	N/A	N/A	Flare Type RT	N/A
N/A	Flare Slope LT (%)	N/A	N/A	Flare Slope RT (%)	N/A
N/A	Flare Traversable LT?	N/A	N/A	Flare Traversable RT?	N/A
N/A	Landing Length (in)	N/A	N/A	DWS Provided?	N/A
N/A	Landing Width (in)	N/A	N/A	DWS Contrast?	N/A
N/A	Landing Slope (%)	N/A	N/A	DWS Length (in)	N/A
N/A	Landing X Slope (%)	N/A	N/A	DWS Full Width?	N/A
N/A	Landing Curb? (Y/N)	N/A	N/A	DWS Offset (in)	N/A
N/A	Shared Landing?	N/A			
N/A	Gutter Ponding?	N/A	N/A	Gutter Slope (%)	N/A
N/A	Gutter Lip Ht (in)	N/A	N/A	Gutter X Slope (%)	N/A
N/A	Painted X Walk1?	No	N/A	Painted X Walk2?	N/A
	X Walk 1 Direction	To SE		X Walk 2 Direction	N/A
N/A	X Walk 1 Width (in)	N/A	N/A	X Walk 2 Width (in)	N/A
	X Walk 1 Slope (%)	2.2		X Walk 2 Slope (%)	N/A
	X Walk 1 X Slope (%)	3.9		X Walk 2 X Slope (%)	N/A

Possible Solutions:

Remove & Replace Entire Ramp.

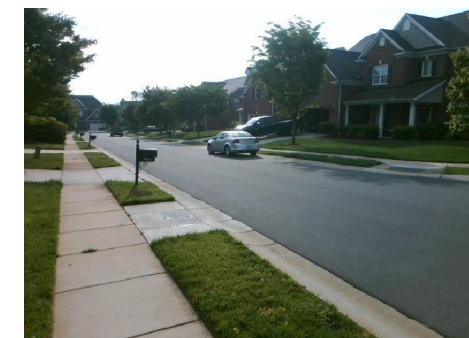
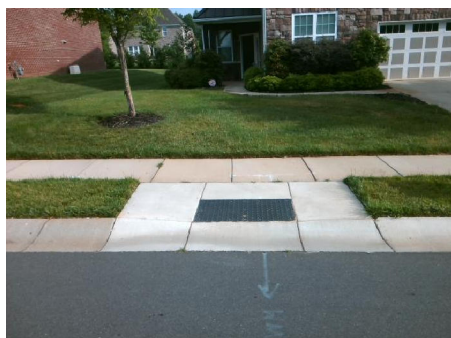
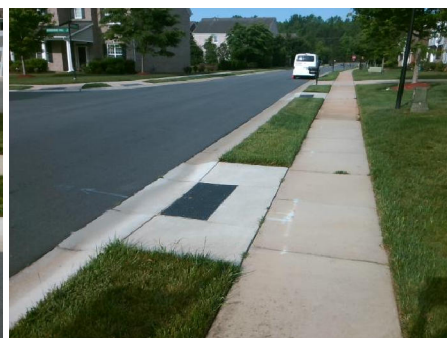
N/A	Ramp inside XWalk1?	N/A	N/A	Ramp inside XWalk2?	N/A
	Road Slope (%)	N/A	N/A	Clear Space?	N/A
	Road X Slope (%)	N/A	N/A	Clear Space to XWalk (in)	N/A
N/A	Any Obstructions?	N/A	N/A	Storm Grate/Utility Hazard?	N/A
	Obstruction Type			Storm Grate/Utility Type	
		N/A			N/A
			Yes	Surface Condition? (G/P)	Good
