# Access Compliance Report

## Public Rights-of-Way

### (Curb Ramps)

| Intersection ID: 13763 | Main Street: CENTRAL_AV | Cross Street: EASTWAY_DR | Location: SW |

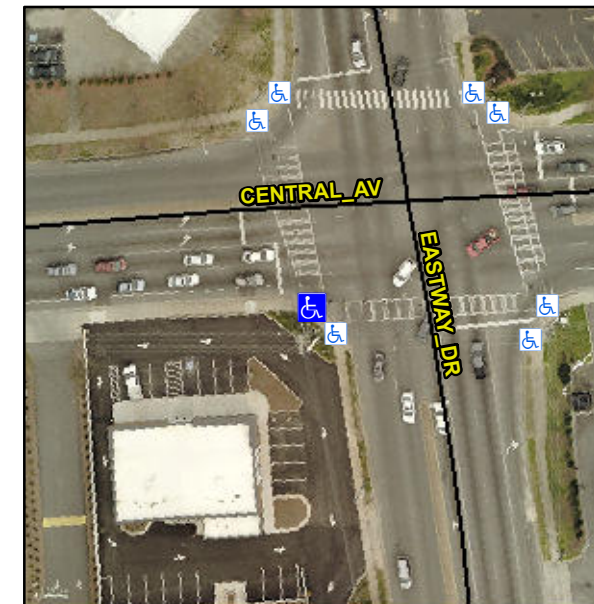
| ADA ID: 86E18DBF6A69 | Ramp Type: Perp | Initial Pass/Fail: Fail | Overall Compliance: No |
| | | Severity Score: 10 | |

**Not Found, R304.5.1, R304.5.3**

| Compliance | Description | Data | Compliance | Description | Data |
|---|---|---|---|---|---|
| N/A | Ramp Length (in) | 72.0 | Yes | Ramp Slope (%) | 6.4 |
| No | Ramp Width (in) | 39.0 | No | Ramp XSlope (%) | 2.9 |

Possible Solutions:

**Remove & Replace Entire Ramp.**

Total Cost: \$ 1850.00

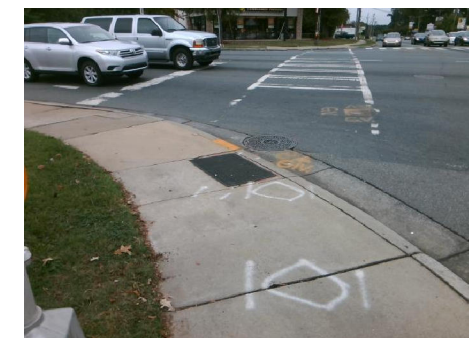
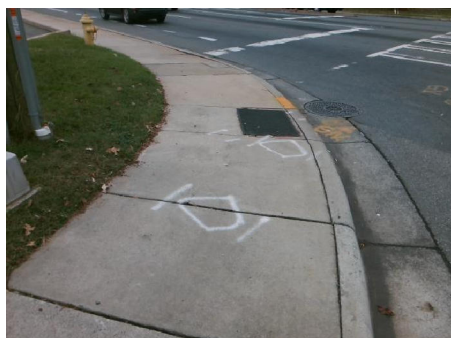
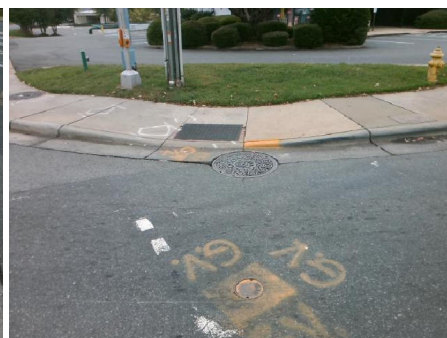
| Compliance | Description | Data | Compliance | Description | Data |
|---|---|---|---|---|---|
| | | Yes | | Surface Condition? (G/P) | Good |
