Access Compliance Report

Public Rights-of-Way

(Curb Ramps)

Intersection ID: 10013227	Main Street: THE_PLAZA	Cross Street: N/A	Location: SE
ADA ID: 86E1E2FF34AE	Ramp Type: Para	Initial Pass/Fail: Pass	Overall Compliance: No
		Severity Score: 0	
Codes/Mitigation Info/Possible Solution		Field Measurements/Component Compliance

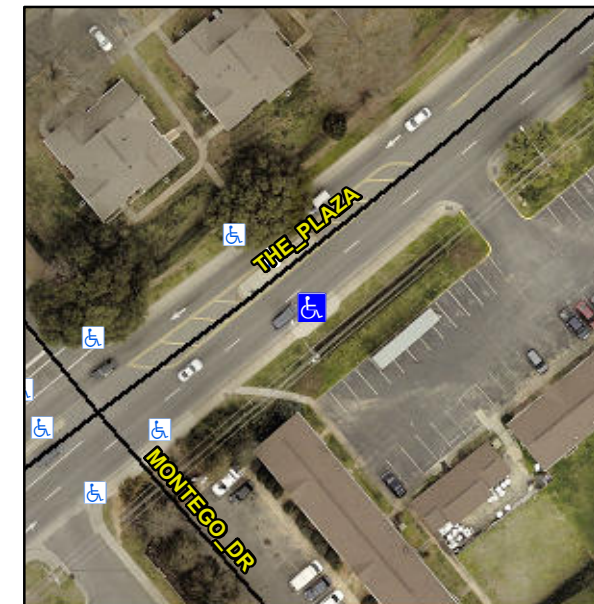
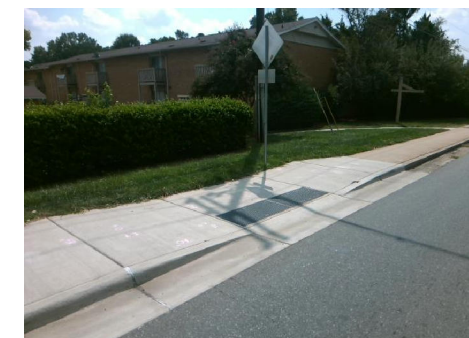
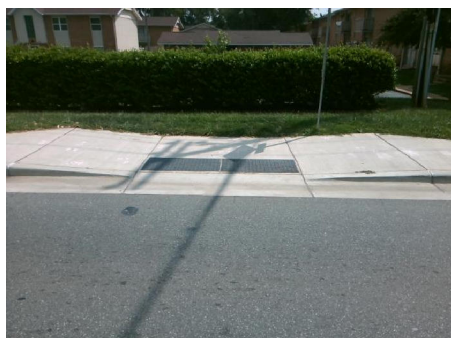
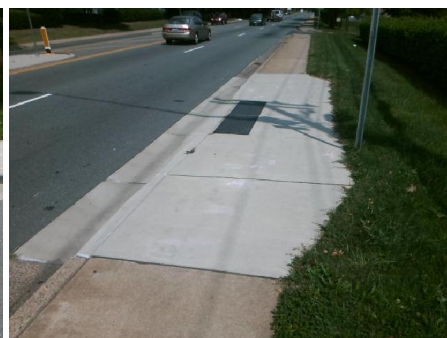
Not Found, R305.2

Compliance	Description	Data	Compliance	Description	Data
N/A	Ramp Length LT (in)	70.0	N/A	Ramp Length RT (in)	71.0
Yes	Ramp Width LT (in)	84.0	Yes	Ramp Width RT (in)	84.0
Yes	Ramp Slope LT (%)	7.7	Yes	Ramp Slope RT (%)	5.0
Yes	Ramp XSlope LT (%)	0.4	Yes	Ramp XSlope RT (%)	1.7
Yes	Landing Length (in)	84.0	Yes	DWS Provided?	Yes
Yes	Landing Width (in)	97.0	Yes	DWS Contrast?	Yes
Yes	Landing Slope (%)	1.2	Yes	DWS Length (in)	24.0
Yes	Landing X Slope (%)	0.4	Yes	DWS Full Width?	Yes
N/A	Landing Curb? (Y/N)	No	No	DWS Offset (in)	2.5
N/A	Shared Landing?	No			
Yes	Gutter Ponding?	No	Yes	Gutter Slope (%)	3.3
Yes	Gutter Lip Ht (in)	0.0	Yes	Gutter X Slope (%)	1.8
N/A	Painted X Walk1?	No	N/A	Painted X Walk2?	N/A
	X Walk 1 Direction	To NW		X Walk 2 Direction	N/A
N/A	X Walk 1 Width (in)	N/A	N/A	X Walk 2 Width (in)	N/A
	X Walk 1 Slope (%)	4.0		X Walk 2 Slope (%)	N/A
	X Walk 1 X Slope (%)	0.7		X Walk 2 X Slope (%)	N/A
N/A	Ramp inside XWalk1?	N/A	N/A	Ramp inside XWalk2?	N/A

Road Slope (%)	N/A	N/A	Clear Space?	Yes
	Road X Slope (%)	N/A	N/A	Clear Space to XWalk (in)	N/A
Yes	Any Obstructions?	No	Yes	Storm Grate/Utility Hazard?	No
	Obstruction Type			Storm Grate/Utility Type	
		N/A			N/A
			Yes	Surface Condition? (G/P)	Good
			Replace	Curb Slope (%)	8.6

Possible Solutions:

Remove & Replace Entire Ramp.
