# Access Compliance Report

## Public Rights-of-Way

### (Curb Ramps)

Intersection ID: 17409	Main Street: HILLSIDE_AV	Cross Street: PARK_RD	Location: SE
ADA ID: 86EE88FB1F28	Ramp Type: Perp	Initial Pass/Fail: Fail	Overall Compliance: No
Codes/Mitigation Info/Possible Solution		Field Measurements/Component Compliance

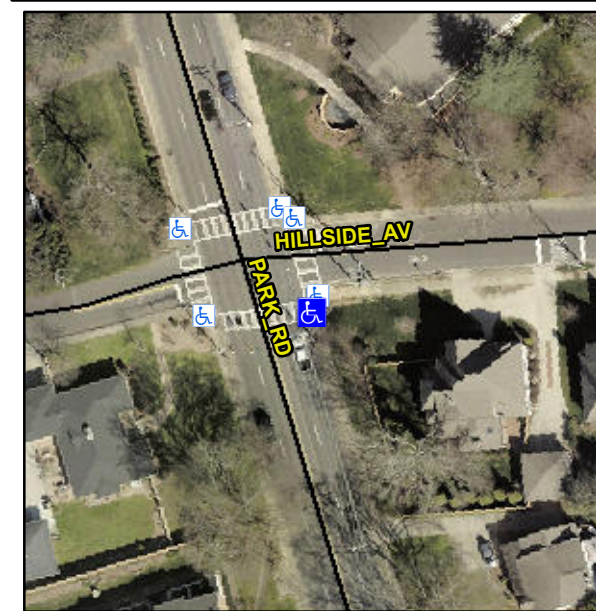
**Not Found, R304.5.1, R304.5.3**

Compliance	Description	Data	Compliance	Description	Data
N/A	Ramp Length (in)	71.0	Yes	Ramp Slope (%)	6.7
No	Ramp Width (in)	35.0	No	Ramp XSlope (%)	3.2
N/A	Flare Type LT	N/A	N/A	Flare Type RT	N/A
N/A	Flare Slope LT (%)	N/A	N/A	Flare Slope RT (%)	N/A
N/A	Flare Traversable LT?	N/A	N/A	Flare Traversable RT?	N/A
N/A	Landing Length (in)	N/A	N/A	DWS Provided?	N/A
N/A	Landing Width (in)	N/A	N/A	DWS Contrast?	N/A
N/A	Landing Slope (%)	N/A	N/A	DWS Length (in)	N/A
N/A	Landing X Slope (%)	N/A	N/A	DWS Full Width?	N/A
N/A	Landing Curb? (Y/N)	N/A	N/A	DWS Offset (in)	N/A
N/A	Shared Landing?	N/A			
N/A	Gutter Ponding?	N/A	N/A	Gutter Slope (%)	N/A
N/A	Gutter Lip Ht (in)	N/A	N/A	Gutter X Slope (%)	N/A
N/A	Painted X Walk1?	Yes	N/A	Painted X Walk2?	N/A
	X Walk 1 Direction	To W		X Walk 2 Direction	N/A
N/A	X Walk 1 Width (in)	106.0	N/A	X Walk 2 Width (in)	N/A
	X Walk 1 Slope (%)	7.2		X Walk 2 Slope (%)	N/A
	X Walk 1 X Slope (%)	1.0		X Walk 2 X Slope (%)	N/A

N/A	Ramp inside XWalk1?	Yes	N/A	Ramp inside XWalk2?	N/A
	Road Slope (%)	N/A	N/A	Clear Space?	N/A
	Road X Slope (%)	N/A	N/A	Clear Space to XWalk (in)	N/A
N/A	Any Obstructions?	N/A	N/A	Storm Grate/Utility Hazard?	N/A
	Obstruction Type			Storm Grate/Utility Type	
		N/A			N/A
			Yes	Surface Condition? (G/P)	Good

**Remove & Replace Entire Ramp.**

Total Cost: \$ 1850.00
