# Access Compliance Report

## Public Rights-of-Way (Curb Ramps)

Intersection ID: 11208	Main Street: PARKWOOD_AV	Cross Street: N_BREVARD_ST	Location: SW
ADA ID: 870333C840F5	Ramp Type: Para	Initial Pass/Fail: Pass	Overall Compliance: No Severity Score: 5

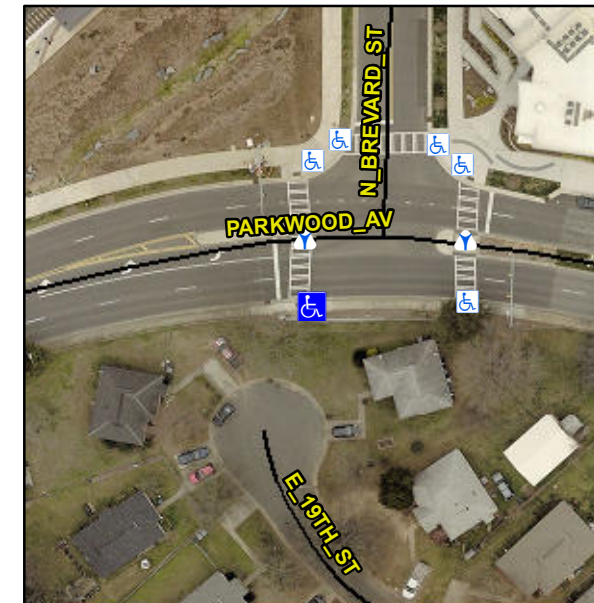
Compliance	Description	Data	Compliance	Description	Data
N/A	Ramp Length LT (in)	127.0	N/A	Ramp Length RT (in)	120.0
Yes	Ramp Width LT (in)	60.0	Yes	Ramp Width RT (in)	60.0
Yes	Ramp Slope LT (%)	5.1	Yes	Ramp Slope RT (%)	6.2
Yes	Ramp XSlope LT (%)	1.9	Yes	Ramp XSlope RT (%)	1.0
Yes	Landing Length (in)	60.0	Yes	DWS Provided?	Yes
Yes	Landing Width (in)	48.0	Yes	DWS Contrast?	Yes
Yes	Landing Slope (%)	0.9	Yes	DWS Length (in)	24.0
Yes	Landing X Slope (%)	1.1	Yes	DWS Full Width?	Yes
N/A	Landing Curb? (Y/N)	No	Yes	DWS Offset (in)	1.0
N/A	Shared Landing?	No			
Yes	Gutter Ponding?	No	No	Gutter Slope (%)	5.8
Yes	Gutter Lip Ht (in)	0.0	Yes	Gutter X Slope (%)	0.2
N/A	Painted X Walk1?	Yes	N/A	Painted X Walk2?	N/A
	X Walk 1 Direction	To N		X Walk 2 Direction	N/A
N/A	X Walk 1 Width (in)	110.0	N/A	X Walk 2 Width (in)	N/A
	X Walk 1 Slope (%)	2.9		X Walk 2 Slope (%)	N/A
	X Walk 1 X Slope (%)	0.6		X Walk 2 X Slope (%)	N/A
Yes	Ramp inside XWalk1?	Yes	N/A	Ramp inside XWalk2?	N/A

Road Slope (%)	N/A	N/A	Clear Space?	Yes
	Road X Slope (%)	N/A	N/A	Clear Space to XWalk (in)	N/A
Yes	Any Obstructions?	No	Yes	Storm Grate/Utility Hazard?	No
	Obstruction Type			Storm Grate/Utility Type	
		N/A			N/A
			Yes	Surface Condition? (G/P)	Good
			Compliant	Curb Slope (%)	4.9

**Remove & Replace Gutter.**

**R304.5.4**

Total Cost: \$ 750.00
