Access Compliance Report

Public Rights-of-Way

(Curb Ramps)

Intersection ID: 13908	Main Street: BAY_ST	Cross Street: ST_JULIEN_ST	Location:	N
ADA ID: 87073E6D2C4A	Ramp Type: Perp	Initial Pass/Fail: Fail	Overall Compliance: No	Severity Score: 8.75
Codes/Mitigation Info/Possible Solution		Field Measurements/Component Compliance

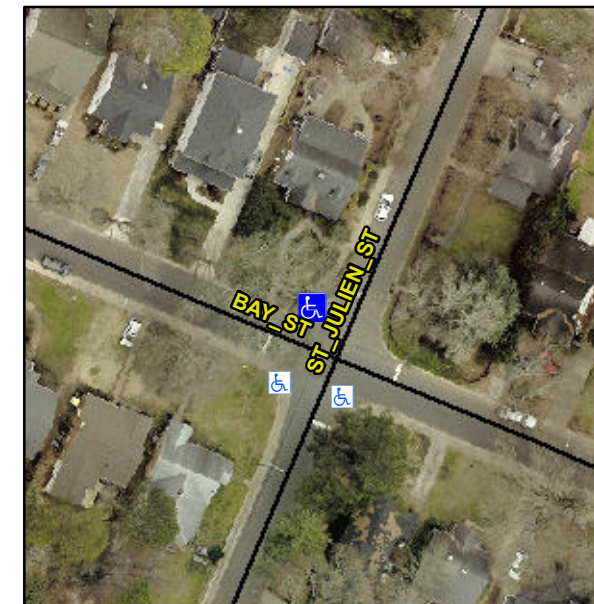
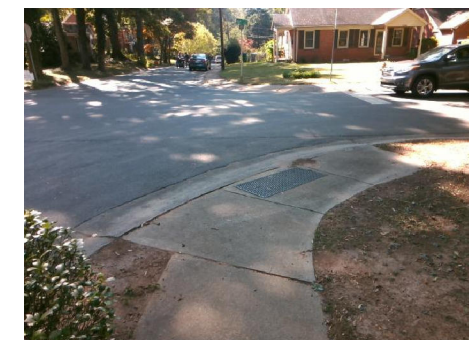
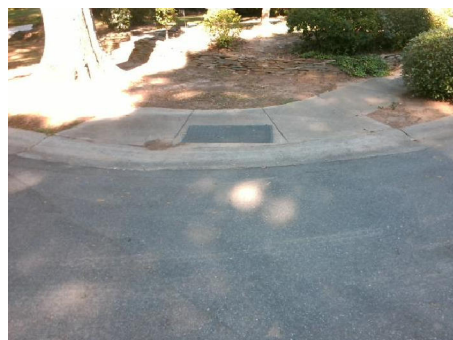
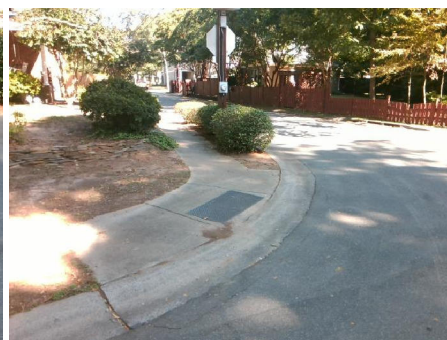
Not Found, R304.5.1

Compliance	Description	Data	Compliance	Description	Data
N/A	Ramp Length (in)	59.0	Yes	Ramp Slope (%)	5.4
No	Ramp Width (in)	44.5	Yes	Ramp XSlope (%)	2.0
N/A	Flare Type LT	N/A	N/A	Flare Type RT	N/A
N/A	Flare Slope LT (%)	N/A	N/A	Flare Slope RT (%)	N/A
N/A	Flare Traversable LT?	N/A	N/A	Flare Traversable RT?	N/A
N/A	Landing Length (in)	N/A	N/A	DWS Provided?	N/A
N/A	Landing Width (in)	N/A	N/A	DWS Contrast?	N/A
N/A	Landing Slope (%)	N/A	N/A	DWS Length (in)	N/A
N/A	Landing X Slope (%)	N/A	N/A	DWS Full Width?	N/A
N/A	Landing Curb? (Y/N)	N/A	N/A	DWS Offset (in)	N/A
N/A	Shared Landing?	N/A			
N/A	Gutter Ponding?	N/A	N/A	Gutter Slope (%)	N/A
N/A	Gutter Lip Ht (in)	N/A	N/A	Gutter X Slope (%)	N/A
N/A	Painted X Walk1?	No	N/A	Painted X Walk2?	N/A
	X Walk 1 Direction	To SW		X Walk 2 Direction	N/A
N/A	X Walk 1 Width (in)	N/A	N/A	X Walk 2 Width (in)	N/A
	X Walk 1 Slope (%)	0.2		X Walk 2 Slope (%)	N/A
	X Walk 1 X Slope (%)	0.4		X Walk 2 X Slope (%)	N/A

N/A	Ramp inside XWalk1?	N/A	N/A	Ramp inside XWalk2?	N/A
	Road Slope (%)	N/A	N/A	Clear Space?	N/A
	Road X Slope (%)	N/A	N/A	Clear Space to XWalk (in)	N/A
N/A	Any Obstructions?	N/A	N/A	Storm Grate/Utility Hazard?	N/A
	Obstruction Type			Storm Grate/Utility Type	
		N/A			N/A
			Yes	Surface Condition? (G/P)	Good

Remove & Replace Entire Ramp.
