Access Compliance Report

Public Rights-of-Way

(Curb Ramps)

Intersection ID: 11695	Main Street: PARKWOOD_AV	Cross Street: THE_PLAZA	Location: W
ADA ID: 870B709EEBDE	Ramp Type: Perp	Initial Pass/Fail: Fail	Overall Compliance: No
Severity Score: 25			
Codes/Mitigation Info/Possible Solution		Field Measurements/Component Compliance

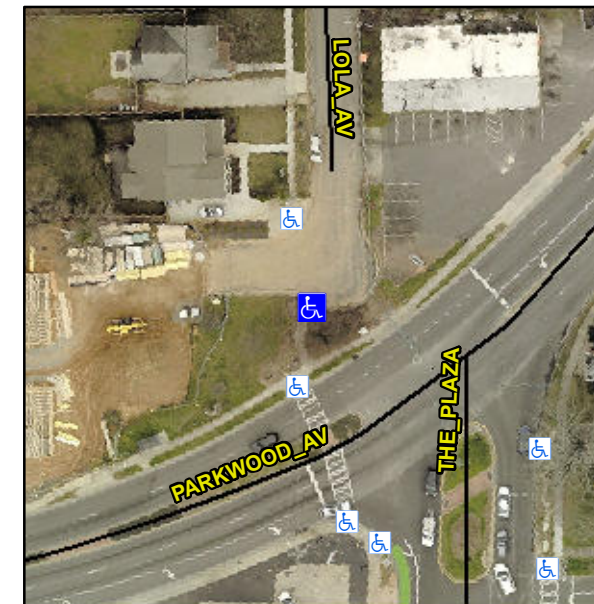
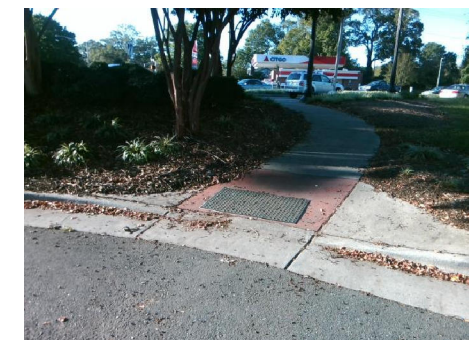
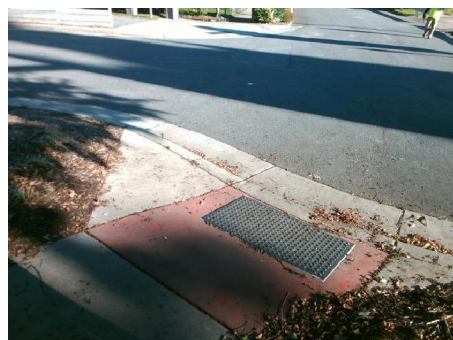
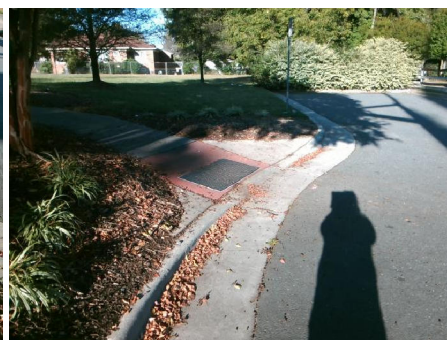
Not Found, R304.2.2

Compliance	Description	Data	Compliance	Description	Data
N/A	Ramp Length (in)	60.0	No	Ramp Slope (%)	13.4
Yes	Ramp Width (in)	66.0	Yes	Ramp XSlope (%)	0.5
N/A	Flare Type LT	N/A	N/A	Flare Type RT	N/A
N/A	Flare Slope LT (%)	N/A	N/A	Flare Slope RT (%)	N/A
N/A	Flare Traversable LT?	N/A	N/A	Flare Traversable RT?	N/A
N/A	Landing Length (in)	N/A	N/A	DWS Provided?	N/A
N/A	Landing Width (in)	N/A	N/A	DWS Contrast?	N/A
N/A	Landing Slope (%)	N/A	N/A	DWS Length (in)	N/A
N/A	Landing X Slope (%)	N/A	N/A	DWS Full Width?	N/A
N/A	Landing Curb? (Y/N)	N/A	N/A	DWS Offset (in)	N/A
N/A	Shared Landing?	N/A			
N/A	Gutter Ponding?	N/A	N/A	Gutter Slope (%)	N/A
N/A	Gutter Lip Ht (in)	N/A	N/A	Gutter X Slope (%)	N/A
N/A	Painted X Walk1?	No	N/A	Painted X Walk2?	N/A
	X Walk 1 Direction	To NW		X Walk 2 Direction	N/A
N/A	X Walk 1 Width (in)	N/A	N/A	X Walk 2 Width (in)	N/A
	X Walk 1 Slope (%)	0.8		X Walk 2 Slope (%)	N/A
	X Walk 1 X Slope (%)	0.7		X Walk 2 X Slope (%)	N/A

N/A	Ramp inside XWalk1?	N/A	N/A	Ramp inside XWalk2?	N/A
	Road Slope (%)	N/A	N/A	Clear Space?	N/A
	Road X Slope (%)	N/A	N/A	Clear Space to XWalk (in)	N/A
N/A	Any Obstructions?	N/A	N/A	Storm Grate/Utility Hazard?	N/A
	Obstruction Type			Storm Grate/Utility Type	
		N/A			N/A
		Yes		Surface Condition? (G/P)	Good

Remove & Replace Entire Ramp.
