# Access Compliance Report

## Public Rights-of-Way

### (Curb Ramps)

| Intersection ID: 10027854 | Main Street: HAMILTON_RD | Cross Street: N/A | Location: NW |

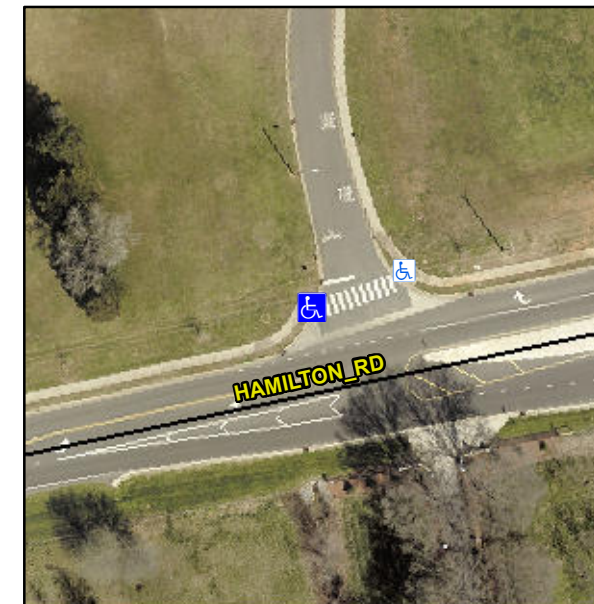
| ADA ID: 870C8657B733 | Ramp Type: PerpDiag | Initial Pass/Fail: Fail | Overall Compliance: No |
| | | Severity Score: 25 | |

| Compliance | Description | Data | Compliance | Description | Data |
|---|---|---|---|---|---|
| N/A | Ramp Length (in) | 48.0 | No | Ramp Slope (%) | 14.0 |
| Yes | Ramp Width (in) | 48.0 | Yes | Ramp XSlope (%) | 0.2 |

**Remove & Replace Curb Ramp With Two New Directional Ramps or Equivalent.**

**R304.2.2**

**\$ 3200.00**
