## Access Compliance Report Public Rights-of-Way (Curb Ramps)

Intersection ID: 43409Main Street:E\_E\_WADDELL\_DRCross Street:NATIONS\_FORD\_RDLocation:NWADA ID: 872D4CDB3855Ramp Type:PerpDiagInitial Pass/Fail:FailOverall Compliance:NoSeverity Score:12.5

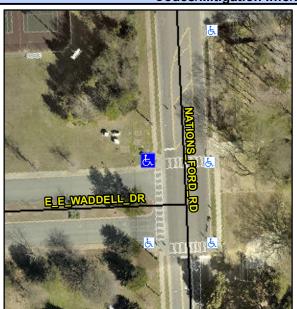
Not Found, R304.5.3

Field Measurements/Component Compliance					
Compliance Description		Data	Comp	oliance Description	Data
N/A	A Ramp Length (in)	109.0	Yes	Ramp Slope (%)	5.2
Ye	s Ramp Width (in)	48.0	No	Ramp XSlope (%)	5.2
N/A	A Flare Type LT	N/A	N/A	Flare Type RT	N/A
N/A	A Flare Slope LT (%)	N/A	N/A	Flare Slope RT (%)	N/A
N/A	A Flare Traversable LT?	N/A	N/A	Flare Traversable RT?	N/A
N/A	A Landing Length (in)	N/A	N/A	DWS Provided?	N/A
N/A	A Landing Width (in)	N/A	N/A	DWS Contrast?	N/A
N/A	<b>A</b> Landing Slope (%)	N/A	N/A	DWS Length (in)	N/A
N/A	A Landing X Slope (%)	N/A	N/A	DWS Full Width?	N/A
N/A	A Landing Curb? (Y/N)	N/A	N/A	DWS Offset (in)	N/A
N/A	A Shared Landing?	N/A			
N/A	A Gutter Ponding?	N/A	N/A	Gutter Slope (%)	N/A
N/A	Gutter Lip Ht (in)	N/A	N/A	Gutter X Slope (%)	N/A
N/A	A Painted X Walk1?	Yes	N/A	Painted X Walk2?	Yes
	X Walk 1 Direction	To S		X Walk 2 Direction	To E
N/A	X Walk 1 Width (in)	70.0	N/A	X Walk 2 Width (in)	112.0

X Walk 1 Slope (%)	1.2		X Walk 2 Slope (%)	2.1
	X Walk 1 X Slope (%)	2.9		X Walk 2 X Slope (%)	1.8
N/A	A Ramp inside XWalk1?	Yes	N/A	Ramp inside XWalk2?	Yes
	Road Slope (%)	0.9	N/A	Clear Space?	N/A
	Road X Slope (%)	4.3	N/A	Clear Space to XWalk (in)	N/A
N/	Any Obstructions?	N/A	N/A	Storm Grate/Utility Hazard?	N/A
	Obstruction Type			Storm Grate/Utility Type	
		N/A			N/A
			Yes	Surface Condition? (G/P)	Good

Remove & Replace Curb Ramp With
Two New Directional Ramps or
Equivalent.

Total Cost: \$ 3200.00
