## **Access Compliance Report Public Rights-of-Way** (Curb Ramps)

Intersection ID: 50613 Main Street: BALSAM BAY RD Cross Street: DOWNY\_BIRCH\_RD Location: NW **Overall Compliance: No ADA ID: 874EACECADF5** Ramp Type: Perp Initial Pass/Fail: Pass **Severity Score:** 5.25

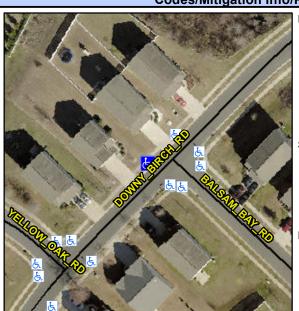
Field Measurements/Component Compliance						
Compliance Description D		Data	Comp	oliance Description	Data	
N/A	Ramp Length (in)	46.5	Yes	Ramp Slope (%)	5.6	
Yes	Ramp Width (in)	48.0	No	Ramp XSlope (%)	3.2	
N/A	Flare Type LT	Sloped	N/A	Flare Type RT	N/A	
N/A	Flare Slope LT (%)	7.8	N/A	Flare Slope RT (%)	0.9	
N/A	Flare Traversable LT?	No	N/A	Flare Traversable RT?	No	
Yes	Landing Length (in)	48.0	Yes	DWS Provided?	Yes	
Yes	Landing Width (in)	48.0	Yes	DWS Contrast?	Yes	
Yes	Landing Slope (%)	1.7	Yes	DWS Length (in)	24.0	
No	Landing X Slope (%)	3.5	Yes	DWS Full Width?	Yes	
N/A	Landing Curb? (Y/N)	No	No	DWS Offset (in)	3.5	
N/A	Shared Landing?	Yes				
Yes	Gutter Ponding?	No	No	Gutter Slope (%)	10.5	
Yes	Gutter Lip Ht (in)	0.0	No	Gutter X Slope (%)	3.2	
N/A	Painted X Walk1?	No	N/A	Painted X Walk2?	N/A	
	X Walk 1 Direction	To S		X Walk 2 Direction	N/A	
N/A	X Walk 1 Width (in)	N/A	N/A	X Walk 2 Width (in)	N/A	
	X Walk 1 Slope (%)	3.2		X Walk 2 Slope (%)	N/A

X Walk 1 X Slope (%)	3.0		X Walk 2 X Slope (%)	N/A	
N/A	Ramp inside XWalk1?	N/A	N/A	Ramp inside XWalk2?	N/A	
	Road Slope (%)	N/A	N/A	Clear Space?	Yes	
	Road X Slope (%)	N/A	N/A	Clear Space to XWalk (in)	N/A	
Yes	Any Obstructions?	No	Yes	Storm Grate/Utility Hazard?	No	
	Obstruction Type			Storm Grate/Utility Type		
		N/A			N/A	
			Yes	Surface Condition? (G/P)	Good

Possible Solutions: Remove & Replace Entire Ramp. Remove & Replace Gutter. Surveyor Notes: N/A PROW/ADA: Not Found, R304.5.3, R305.2, R304.5.4
