# Access Compliance Report

## Public Rights-of-Way

### (Curb Ramps)

Intersection ID: 21396	Main Street: W_ARROWOOD_RD	Cross Street: FOREST_PINE_DR	Location: NE
ADA ID: 8751D56ACF83	Ramp Type: Combination2Diag	Initial Pass/Fail: Fail	Overall Compliance: No
		Severity Score: 0

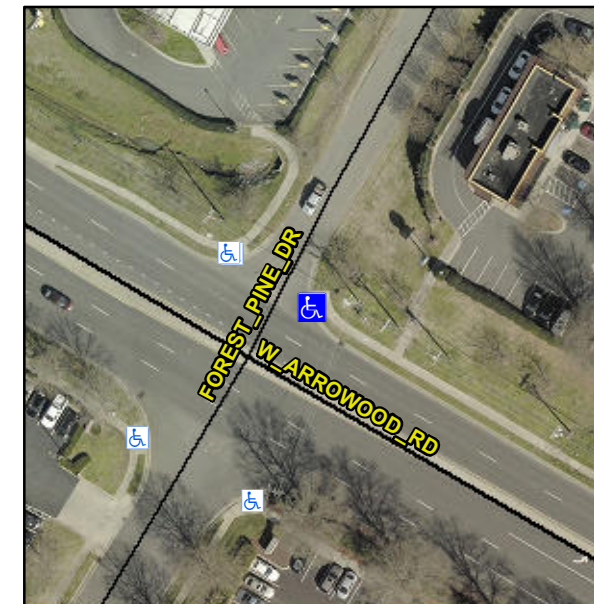
**MEDIAN ACROSS W ARROWOOD RD**

**Not Found, R304.5.1, R304.2.2, R304.5.3**

Compliance	Description	Data	Compliance	Description	Data
N/A	Ramp Length LT (in)	50.0	N/A	Ramp Length RT (in)	N/A
Yes	Ramp Width LT (in)	60.0	N/A	Ramp Width RT (in)	N/A
Yes	Ramp Slope LT (%)	5.8	N/A	Ramp Slope RT (%)	N/A
No	Ramp XSlope LT (%)	4.9	N/A	Ramp XSlope RT (%)	N/A
N/A	Ramp Length (in)	46.0	No	Ramp Slope (%)	9.6
No	Ramp Width (in)	46.0	Yes	Ramp XSlope (%)	1.4
N/A	Flare Type LT	N/A	N/A	Flare Type RT	N/A
N/A	Flare Slope LT (%)	N/A	N/A	Flare Slope RT (%)	N/A
N/A	Flare Traversable LT?	N/A	N/A	Flare Traversable RT?	N/A
N/A	Landing Length (in)	N/A	N/A	DWS Provided?	N/A
N/A	Landing Width (in)	N/A	N/A	DWS Contrast?	N/A
N/A	Landing Slope (%)	N/A	N/A	DWS Length (in)	N/A
N/A	Landing X Slope (%)	N/A	N/A	DWS Full Width?	N/A
N/A	Landing Curb? (Y/N)	N/A	N/A	DWS Offset (in)	N/A
N/A	Shared Landing?	N/A			
N/A	Gutter Ponding?	N/A	N/A	Gutter Slope (%)	N/A
N/A	Gutter Lip Ht (in)	N/A	N/A	Gutter X Slope (%)	N/A
N/A	Painted X Walk1?	No	N/A	Painted X Walk2?	No

X Walk 1 Direction	To NW		X Walk 2 Direction	To S
	X Walk 1 Width (in)	N/A		X Walk 2 Width (in)	N/A
	X Walk 1 Slope (%)	1.6		X Walk 2 Slope (%)	2.3
	X Walk 1 X Slope (%)	2.3		X Walk 2 X Slope (%)	1.1
N/A	Ramp inside XWalk1?	N/A	N/A	Ramp inside XWalk2?	N/A
	Road Slope (%)	1.7		Clear Space?	N/A
	Road X Slope (%)	0.4	N/A	Clear Space to XWalk (in)	N/A
			N/A	Any Obstruction?	N/A
				Obstruction Type	N/A
			N/A	Storm Grate/Utility Hazard?	N/A
				Storm Grate/Utility Type	N/A
					N/A
Yes	Surface Condition? (G/P)	Good			
	Curb Slope (%)	7.7

**Remove & Replace Curb Ramp With Two New Directional Ramps or Equivalent.**
