# Access Compliance Report

## Public Rights-of-Way

### (Curb Ramps)

Intersection ID: 13683	Main Street: ELIZABETH_AV	Cross Street: CHARLOTTETOWNE_AV	Location:	N
ADA ID: 875581BF29BA	Ramp Type: Perp	Initial Pass/Fail: Fail	Overall Compliance: No	Severity Score: 8.75
Codes/Mitigation Info/Possible Solution		Field Measurements/Component Compliance

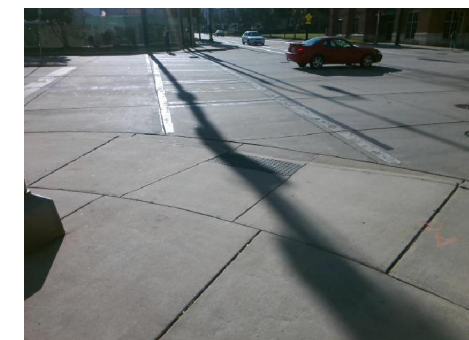
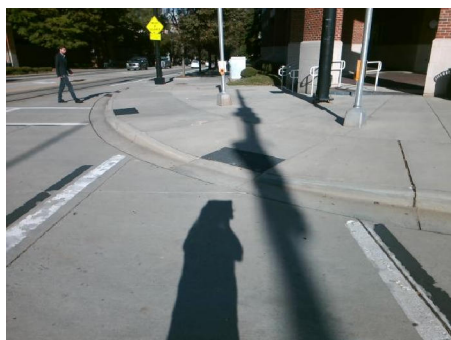
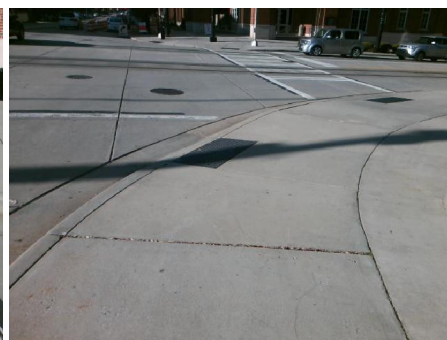
**Not Found, R304.5.1**

Compliance	Description	Data	Compliance	Description	Data
N/A	Ramp Length (in)	85.0	Yes	Ramp Slope (%)	8.0
No	Ramp Width (in)	47.5	Yes	Ramp XSlope (%)	1.6
N/A	Flare Type LT	N/A	N/A	Flare Type RT	N/A
N/A	Flare Slope LT (%)	N/A	N/A	Flare Slope RT (%)	N/A
N/A	Flare Traversable LT?	N/A	N/A	Flare Traversable RT?	N/A
N/A	Landing Length (in)	N/A	N/A	DWS Provided?	N/A
N/A	Landing Width (in)	N/A	N/A	DWS Contrast?	N/A
N/A	Landing Slope (%)	N/A	N/A	DWS Length (in)	N/A
N/A	Landing X Slope (%)	N/A	N/A	DWS Full Width?	N/A
N/A	Landing Curb? (Y/N)	N/A	N/A	DWS Offset (in)	N/A
N/A	Shared Landing?	N/A			
N/A	Gutter Ponding?	N/A	N/A	Gutter Slope (%)	N/A
N/A	Gutter Lip Ht (in)	N/A	N/A	Gutter X Slope (%)	N/A
N/A	Painted X Walk1?	Yes	N/A	Painted X Walk2?	N/A
	X Walk 1 Direction	To SE		X Walk 2 Direction	N/A
N/A	X Walk 1 Width (in)	106.0	N/A	X Walk 2 Width (in)	N/A
	X Walk 1 Slope (%)	3.6		X Walk 2 Slope (%)	N/A
	X Walk 1 X Slope (%)	0.7		X Walk 2 X Slope (%)	N/A

N/A	Ramp inside XWalk1?	Yes	N/A	Ramp inside XWalk2?	N/A
	Road Slope (%)	N/A	N/A	Clear Space?	N/A
	Road X Slope (%)	N/A	N/A	Clear Space to XWalk (in)	N/A
N/A	Any Obstructions?	N/A	N/A	Storm Grate/Utility Hazard?	N/A
	Obstruction Type			Storm Grate/Utility Type	
		N/A			N/A
			Yes	Surface Condition? (G/P)	Good

**Remove & Replace Entire Ramp.**

Total Cost: \$ 1850.00
