Intersection ID: N/A	Main Street: BILLY_GRAHAM_PY	Cross Street: TRYON_ST	Location:	SE
ADA ID: 875E0345EB2D	Ramp Type: PerpDiag	Initial Pass/Fail: Fail	Overall Compliance: No	Severity Score: 21.25

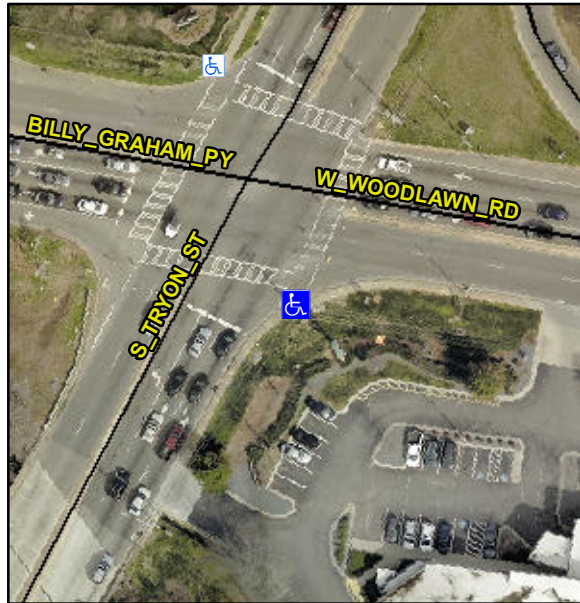
Not Found, R304.5.1, R304.2.2

Compliance	Description	Data	Compliance	Description	Data
N/A	Ramp Length (in)	70.0	No	Ramp Slope (%)	9.2
No	Ramp Width (in)	43.0	Yes	Ramp XSlope (%)	1.2
N/A	Flare Type LT	N/A	N/A	Flare Type RT	N/A
N/A	Flare Slope LT (%)	N/A	N/A	Flare Slope RT (%)	N/A
N/A	Flare Traversable LT?	N/A	N/A	Flare Traversable RT?	N/A
N/A	Landing Length (in)	N/A	N/A	DWS Provided?	N/A
N/A	Landing Width (in)	N/A	N/A	DWS Contrast?	N/A
N/A	Landing Slope (%)	N/A	N/A	DWS Length (in)	N/A
N/A	Landing X Slope (%)	N/A	N/A	DWS Full Width?	N/A
N/A	Landing Curb? (Y/N)	N/A	N/A	DWS Offset (in)	N/A
N/A	Shared Landing?	N/A			
N/A	Gutter Ponding?	N/A	N/A	Gutter Slope (%)	N/A
N/A	Gutter Lip Ht (in)	N/A	N/A	Gutter X Slope (%)	N/A
N/A	Painted X Walk1?	Yes	N/A	Painted X Walk2?	Yes
	X Walk 1 Direction	To NW		X Walk 2 Direction	To NE
N/A	X Walk 1 Width (in)	110.0	N/A	X Walk 2 Width (in)	111.0
	X Walk 1 Slope (%)	1.1		X Walk 2 Slope (%)	1.7
	X Walk 1 X Slope (%)	1.0		X Walk 2 X Slope (%)	1.2

N/A	Ramp inside XWalk1?	No	N/A	Ramp inside XWalk2?	No
	Road Slope (%)	0.5	N/A	Clear Space?	N/A
	Road X Slope (%)	1.9	N/A	Clear Space to XWalk (in)	N/A
N/A	Any Obstructions?	N/A	N/A	Storm Grate/Utility Hazard?	N/A
	Obstruction Type			Storm Grate/Utility Type	
		N/A			N/A
			Yes	Surface Condition? (G/P)	Good

Remove & Replace Curb Ramp With Two New Directional Ramps or Equivalent. Restripe Crosswalk.

Total Cost: \$ 3400.00
