# Access Compliance Report

## Public Rights-of-Way

### (Curb Ramps)

Intersection ID: 44825	Main Street: SPRING_OAK_DR	Cross Street: HIRAM_ST	Location: NE
ADA ID: 87656862F846	Ramp Type: PerpDiag	Initial Pass/Fail: Fail	Overall Compliance: No
			Severity Score: 33.75

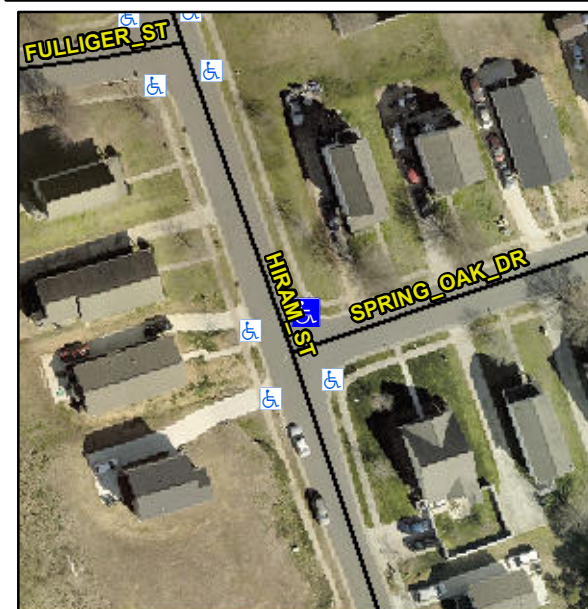
Compliance	Description	Data	Compliance	Description	Data
N/A	Ramp Length (in)	48.0	Yes	Ramp Slope (%)	7.7
No	Ramp Width (in)	42.0	No	Ramp XSlope (%)	14.0
N/A	Flare Type LT	N/A	N/A	Flare Type RT	N/A
N/A	Flare Slope LT (%)	N/A	N/A	Flare Slope RT (%)	N/A
N/A	Flare Traversable LT?	N/A	N/A	Flare Traversable RT?	N/A
N/A	Landing Length (in)	N/A	N/A	DWS Provided?	N/A
N/A	Landing Width (in)	N/A	N/A	DWS Contrast?	N/A
N/A	Landing Slope (%)	N/A	N/A	DWS Length (in)	N/A
N/A	Landing X Slope (%)	N/A	N/A	DWS Full Width?	N/A
N/A	Landing Curb? (Y/N)	N/A	N/A	DWS Offset (in)	N/A
N/A	Shared Landing?	N/A			
N/A	Gutter Ponding?	N/A	N/A	Gutter Slope (%)	N/A
N/A	Gutter Lip Ht (in)	N/A	N/A	Gutter X Slope (%)	N/A
N/A	Painted X Walk1?	No	N/A	Painted X Walk2?	No
	X Walk 1 Direction	To W		X Walk 2 Direction	To S
N/A	X Walk 1 Width (in)	N/A	N/A	X Walk 2 Width (in)	N/A
	X Walk 1 Slope (%)	7.8		X Walk 2 Slope (%)	0.3
	X Walk 1 X Slope (%)	5.1		X Walk 2 X Slope (%)	8.8

N/A	Ramp inside XWalk1?	N/A	N/A	Ramp inside XWalk2?	N/A
	Road Slope (%)	9.7	N/A	Clear Space?	N/A
	Road X Slope (%)	3.0	N/A	Clear Space to XWalk (in)	N/A
N/A	Any Obstructions?	N/A	N/A	Storm Grate/Utility Hazard?	N/A
	Obstruction Type			Storm Grate/Utility Type	
		N/A			N/A
			Yes	Surface Condition? (G/P)	Good

Possible Solutions:

**Remove & Replace Curb Ramp With Two New Directional Ramps or Equivalent.**

PROW/ADA:

**R304.5.1, R304.5.3**

Total Cost: \$ 3200.00
