# Access Compliance Report

## Public Rights-of-Way

### (Curb Ramps)

Intersection ID: 6621	Main Street: MINERAL_SPRINGS_RD	Cross Street: NEAL_RD	Location: NE
ADA ID: 876964FE0D8E	Ramp Type: Perp	Initial Pass/Fail: Fail	Overall Compliance: No
			Severity Score: 21.25

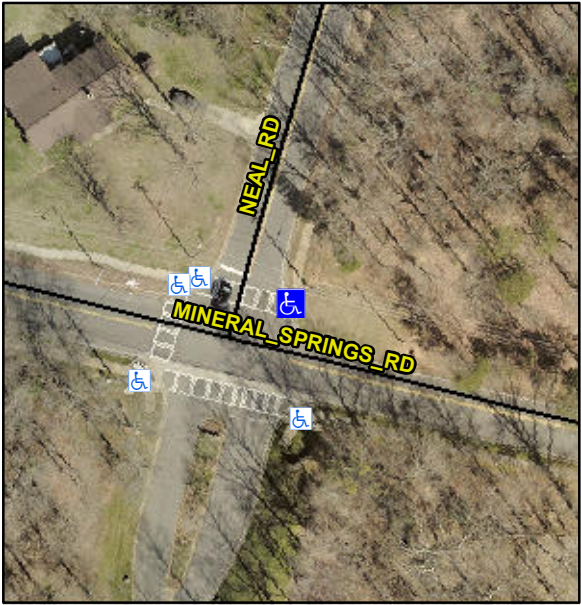
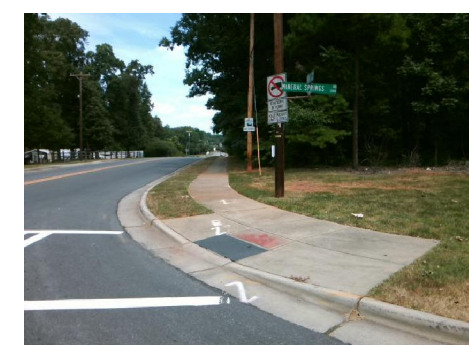
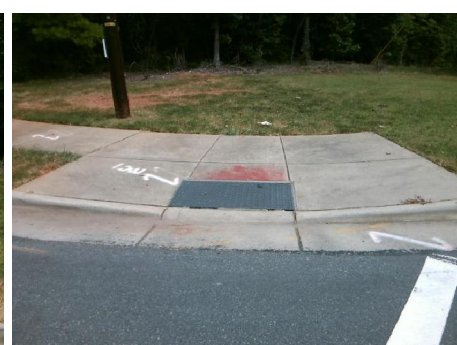
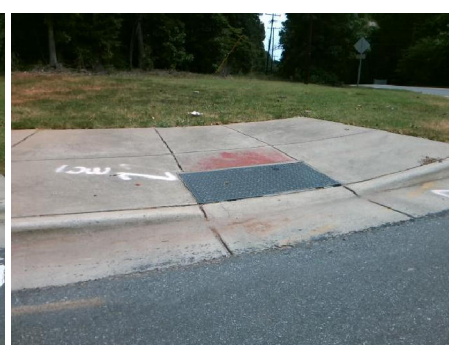
Possible Solutions:		<b>Compliance</b>	<b>Description</b>	<b>Data</b>
	<b>Remove &amp; Replace Entire Ramp.</b>		<b>No</b>	Ramp Length (in)	48.0
			<b>No</b>	Ramp Width (in)	43.0
			<b>N/A</b>	Flare Type LT	N/A
			<b>N/A</b>	Flare Slope LT (%)	N/A
			<b>N/A</b>	Flare Traversable LT?	N/A
			<b>N/A</b>	Landing Length (in)	N/A
			<b>N/A</b>	Landing Width (in)	N/A
			<b>N/A</b>	Landing Slope (%)	N/A
			<b>N/A</b>	Landing X Slope (%)	N/A
<p>Surveyor Notes:</p> <p><b>N/A</b></p> <p>PROW/ADA:</p> <p><b>Not Found, R304.5.1, R304.2.2</b></p>			<b>N/A</b>	Flare Type RT	N/A
			<b>N/A</b>	Flare Slope RT (%)	N/A
			<b>N/A</b>	Flare Traversable RT?	N/A
			<b>N/A</b>	DWS Provided?	N/A
			<b>N/A</b>	DWS Contrast?	N/A
			<b>N/A</b>	DWS Length (in)	N/A
			<b>N/A</b>	DWS Full Width?	N/A
			<b>N/A</b>	DWS Offset (in)	N/A
			<b>N/A</b>	Shared Landing?	N/A

<b>N/A</b>	Gutter Ponding?	N/A
			<b>N/A</b>	Gutter Lip Ht (in)	N/A
			<b>N/A</b>	Painted X Walk1?	Yes
				X Walk 1 Direction	To N
			<b>N/A</b>	X Walk 1 Width (in)	112.0
				X Walk 1 Slope (%)	2.8
				X Walk 1 X Slope (%)	1.8
			<b>N/A</b>	Ramp inside XWalk1?	Yes
			<b>N/A</b>	Road Slope (%)	N/A
			<b>N/A</b>	Road X Slope (%)	N/A
			<b>N/A</b>	Any Obstructions?	N/A
				Obstruction Type	
			<b>N/A</b>		
			<b>N/A</b>		
			<b>N/A</b>		
			<b>N/A</b>		
			<b>N/A</b>		
			<b>N/A</b>		
			<b>N/A</b>		
			<b>N/A</b>		
			<b>N/A</b>		
Total Cost:		\$ 1850.00			
Street 1 Name	NEAL RD				
Stop Condition-Street 2	StopSign				
Street 2 Name	N/A				
Stop Condition-Street 1	N/A
