# Access Compliance Report

## Public Rights-of-Way

### (Curb Ramps)

| Intersection ID: 44158 | Main Street: MEADOW_KNOLL_DR | Cross Street: FEATHER_BEND_CT | Location: NW |

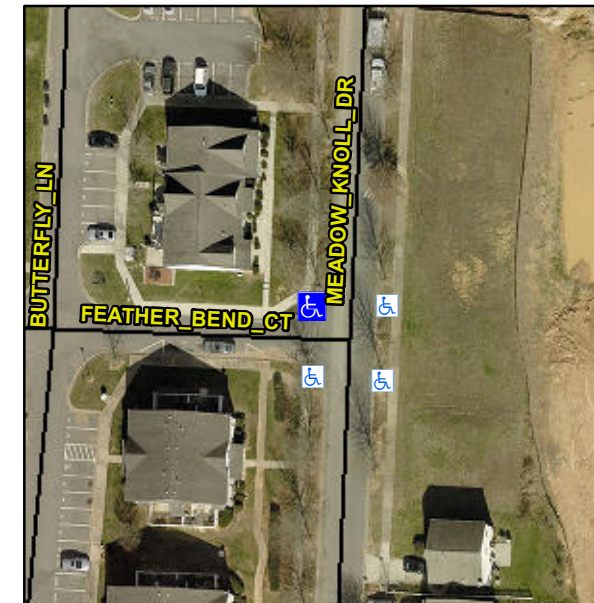
| ADA ID: 8776E833950C | Ramp Type: BlendTrans1 | Initial Pass/Fail: Fail | Overall Compliance: No |

Surveyor Notes:

**LNDG LIP 0.5**

PROW/ADA:

**R304.5.1, R304.5.3**

| Compliance | Description | Data | Compliance | Description | Data |
|---|---|---|---|---|---|
| No | Ramp Width (in) | 46.5 | No | BlendTrans XSlope (%) | 9.9 |

Possible Solutions:

**Remove & Replace Curb Ramp With Two New Directional Ramps or Equivalent.**
