Access Compliance Report Public Rights-of-Way (Curb Ramps)

Intersection ID: 4530	Main Street: BROOKSHIRE_BV	Cross Street: MT_HOLLY-HUNTERSVILLE_RD	Location: SW
ADA ID: 877D62347044	Ramp Type: BlendTrans1	Initial Pass/Fail: Pass	Overall Compliance: No Severity Score: 7.5

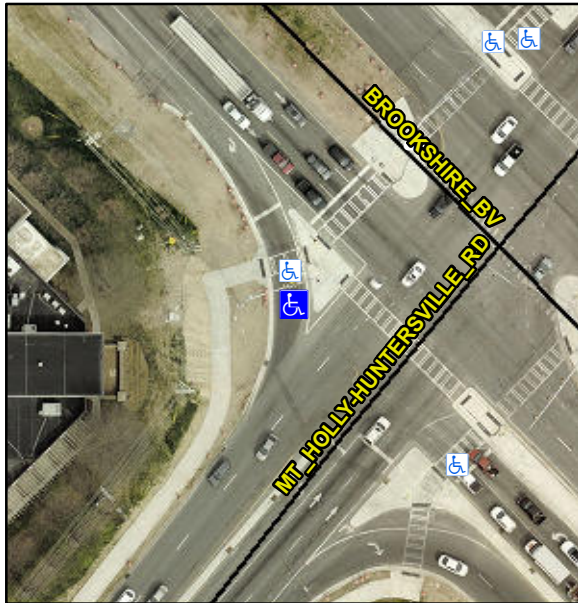
Compliance	Description	Data	Compliance	Description	Data
N/A	Ramp Length (in)	66.0	Yes	BlendTrans Slope (%)	2.4
Yes	Ramp Width (in)	48.0	Yes	BlendTrans XSlope (%)	0.7
N/A	Flare Type LT	Sloped	N/A	Flare Type RT	Sloped
N/A	Flare Slope LT (%)	3.3	N/A	Flare Slope RT (%)	6.2
N/A	Flare Traversable LT?	No	N/A	Flare Traversable RT?	No
Yes	Landing Length (in)	57.5	Yes	DWS Provided?	Yes
Yes	Landing Width (in)	48.0	Yes	DWS Contrast?	Yes
Yes	Landing Slope (%)	1.3	Yes	DWS Length (in)	24.0
Yes	Landing X Slope (%)	1.5	Yes	DWS Full Width?	Yes
N/A	Landing Curb? (Y/N)	No	No	DWS Offset (in)	4.0
N/A	Shared Landing?	No			
Yes	Gutter Ponding?	No	Yes	Gutter Slope (%)	3.6
No	Gutter Lip Ht (in)	0.5	Yes	Gutter X Slope (%)	1.7
N/A	Painted X Walk1?	Yes	N/A	Painted X Walk2?	N/A
	X Walk 1 Direction	To SE		X Walk 2 Direction	N/A
	X Walk 1 Width (in)	112.0		X Walk 2 Width (in)	N/A
	X Walk 1 Slope (%)	2.3		X Walk 2 Slope (%)	N/A
	X Walk 1 X Slope (%)	2.8		X Walk 2 X Slope (%)	N/A

Yes	Ramp inside XWalk1?	Yes	N/A	Ramp inside XWalk2?	N/A
	Road Slope (%)	2.8		Clear Space?	Yes
	Road X Slope (%)	2.3	N/A	Clear Space to XWalk (in)	N/A
Yes	Any Obstructions?	No	Yes	Storm Grate/Utility Hazard?	No
	Obstruction Type			Storm Grate/Utility Type	
			N/A		N/A
Yes	Surface Condition? (G/P)		Good		
Yes	Curb Slope (%)		3.3

Remove & Replace Detectable Warning System. Grind Gutter Lip.

R305.2, R302.7.2
