Access Compliance Report

Public Rights-of-Way

(Curb Ramps)

Intersection ID: 6579	Main Street: MINERAL_SPRINGS_RD	Cross Street: CENTURY_OAKS_LN	Location: NW
ADA ID: 878B2A7A9F4F	Ramp Type: BlendTrans1	Initial Pass/Fail: Fail	Overall Compliance: No
		Severity Score: 1.25

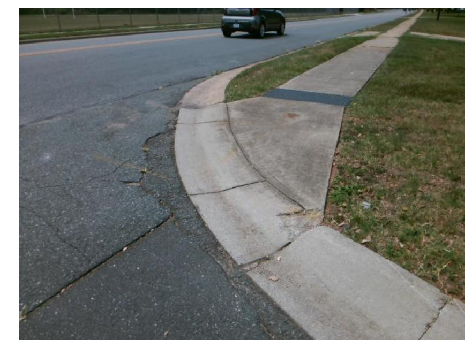
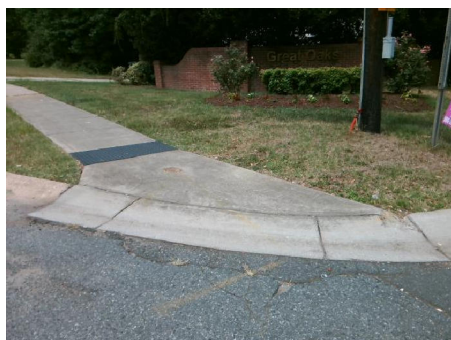
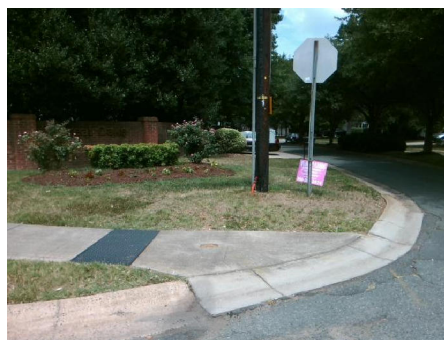
Not Found, R304.5.3

Compliance	Description	Data	Compliance	Description	Data
N/A	Ramp Length (in)	23.0	Yes	BlendTrans Slope (%)	4.6
Yes	Ramp Width (in)	62.0	No	BlendTrans XSlope (%)	3.7
N/A	Flare Type LT	N/A	N/A	Flare Type RT	N/A
N/A	Flare Slope LT (%)	N/A	N/A	Flare Slope RT (%)	N/A
N/A	Flare Traversable LT?	N/A	N/A	Flare Traversable RT?	N/A
N/A	Landing Length (in)	N/A	N/A	DWS Provided?	N/A
N/A	Landing Width (in)	N/A	N/A	DWS Contrast?	N/A
N/A	Landing Slope (%)	N/A	N/A	DWS Length (in)	N/A
N/A	Landing X Slope (%)	N/A	N/A	DWS Full Width?	N/A
N/A	Landing Curb? (Y/N)	N/A	N/A	DWS Offset (in)	N/A
N/A	Shared Landing?	N/A			
N/A	Gutter Ponding?	N/A	N/A	Gutter Slope (%)	N/A
N/A	Gutter Lip Ht (in)	N/A	N/A	Gutter X Slope (%)	N/A
N/A	Painted X Walk1?	No	N/A	Painted X Walk2?	N/A
	X Walk 1 Direction	To SE		X Walk 2 Direction	N/A
	X Walk 1 Width (in)	N/A		X Walk 2 Width (in)	N/A
	X Walk 1 Slope (%)	0.2		X Walk 2 Slope (%)	N/A
	X Walk 1 X Slope (%)	2.1		X Walk 2 X Slope (%)	N/A

N/A	Ramp inside XWalk1?	N/A	N/A	Ramp inside XWalk2?	N/A
	Road Slope (%)	2.1		Clear Space?	N/A
	Road X Slope (%)	0.2	N/A	Clear Space to XWalk (in)	N/A
N/A	Any Obstructions?	N/A	N/A	Storm Grate/Utility Hazard?	N/A
	Obstruction Type			Storm Grate/Utility Type	
		N/A			N/A
			Yes	Surface Condition? (G/P)	Good
			No	Curb Slope (%)	10.4

Remove & Replace Curb Ramp With Two New Directional Ramps or Equivalent.
