# Access Compliance Report

## Public Rights-of-Way

### (Curb Ramps)

| Intersection ID: 10577 | Main Street: JORDAN_PL | Cross Street: N/A | Location: E |

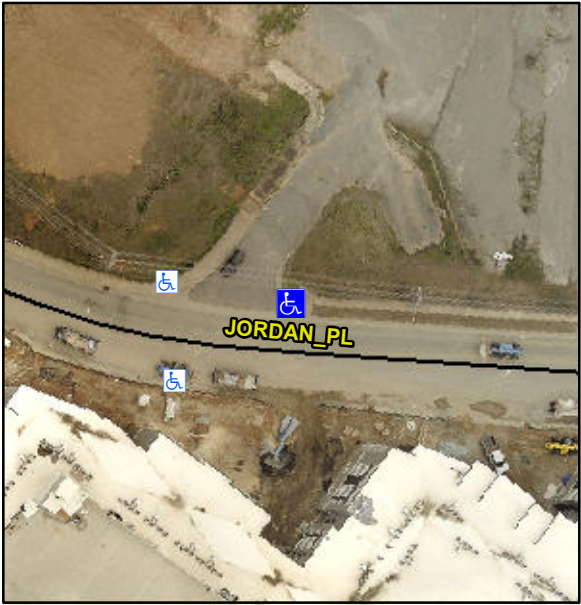
| ADA ID: 878B7927F5F5 | Ramp Type: Perp | Initial Pass/Fail: Fail | Overall Compliance: No |

| Codes/Mitigation Info/Possible Solution | | Field Measurements/Component Compliance | | | | | |
|---|---|---|---|---|---|---|---|
| | Not Found, R304.5.1 | | | | | | |
| | | No | Ramp Width (in) | 30.5 | Yes | Ramp XSlope (%) | 4.5 |

| Codes/Mitigation Info/Possible Solution | | Field Measurements/Component Compliance | | | | | |
|---|---|---|---|---|---|---|---|
| | Remove & Replace Entire Ramp. | | | | | | |
