Access Compliance Report

Public Rights-of-Way

(Curb Ramps)

Intersection ID: 13770	Main Street: HAWKINS_ST	Cross Street: W_KINGSTON_AV	Location: W
ADA ID: 878B9F02A2F8	Ramp Type: Perp	Initial Pass/Fail: Fail	Overall Compliance: No
		Severity Score: 60

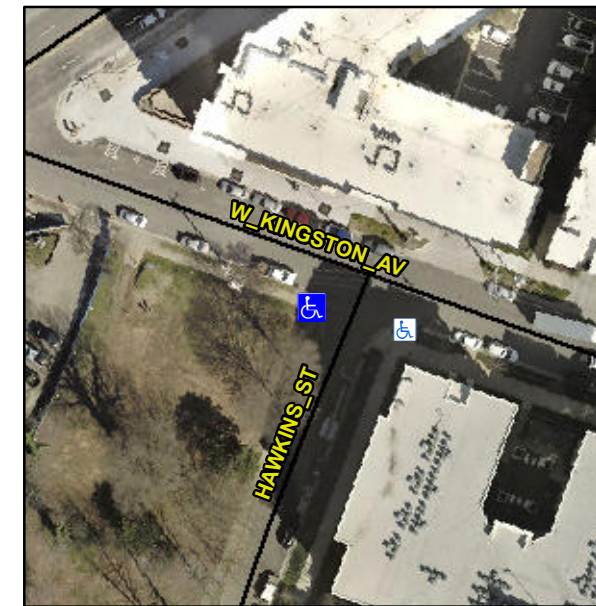
Not Found, R304.5.1, R304.5.3

Compliance	Description	Data	Compliance	Description	Data
N/A	Ramp Length (in)	75.0	Yes	Ramp Slope (%)	5.6
No	Ramp Width (in)	28.0	No	Ramp XSlope (%)	8.7
N/A	Flare Type LT	N/A	N/A	Flare Type RT	N/A
N/A	Flare Slope LT (%)	N/A	N/A	Flare Slope RT (%)	N/A
N/A	Flare Traversable LT?	N/A	N/A	Flare Traversable RT?	N/A
N/A	Landing Length (in)	N/A	N/A	DWS Provided?	N/A
N/A	Landing Width (in)	N/A	N/A	DWS Contrast?	N/A
N/A	Landing Slope (%)	N/A	N/A	DWS Length (in)	N/A
N/A	Landing X Slope (%)	N/A	N/A	DWS Full Width?	N/A
N/A	Landing Curb? (Y/N)	N/A	N/A	DWS Offset (in)	N/A
N/A	Shared Landing?	N/A			
N/A	Gutter Ponding?	N/A	N/A	Gutter Slope (%)	N/A
N/A	Gutter Lip Ht (in)	N/A	N/A	Gutter X Slope (%)	N/A
N/A	Painted X Walk1?	No	N/A	Painted X Walk2?	N/A
	X Walk 1 Direction	To SE		X Walk 2 Direction	N/A
N/A	X Walk 1 Width (in)	N/A	N/A	X Walk 2 Width (in)	N/A
	X Walk 1 Slope (%)	3.0		X Walk 2 Slope (%)	N/A
	X Walk 1 X Slope (%)	4.0		X Walk 2 X Slope (%)	N/A

N/A	Ramp inside XWalk1?	N/A	N/A	Ramp inside XWalk2?	N/A
	Road Slope (%)	7.8	N/A	Clear Space?	N/A
	Road X Slope (%)	1.3	N/A	Clear Space to XWalk (in)	N/A
N/A	Any Obstructions?	N/A	N/A	Storm Grate/Utility Hazard?	N/A
	Obstruction Type			Storm Grate/Utility Type	
		N/A			N/A
		Yes		Surface Condition? (G/P)	Good

Remove & Replace Entire Ramp.

Total Cost: \$ 1850.00
