Access Compliance Report

Public Rights-of-Way

(Curb Ramps)

Intersection ID: 5816	Main Street: PLEASANT GROVE RD	Cross Street: OAKDALE RD	Location: SW
ADA ID: 878EAC332510	Ramp Type: Perp	Initial Pass/Fail: Fail	Overall Compliance: No
Severity Score: 12.5			
Codes/Mitigation Info/Possible Solution		Field Measurements/Component Compliance

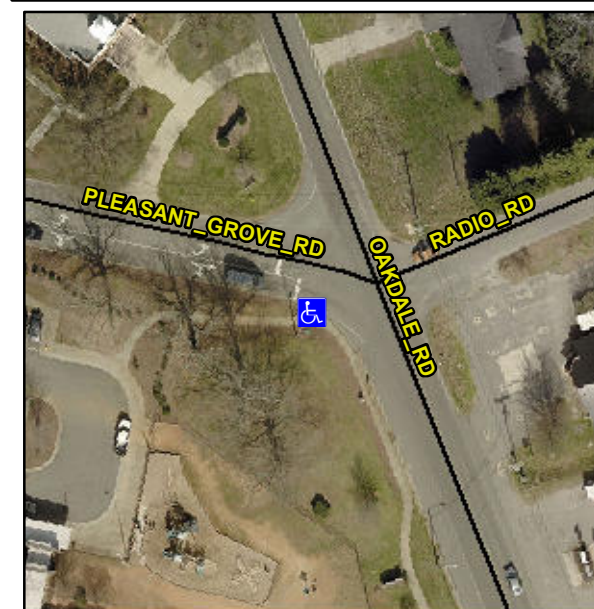
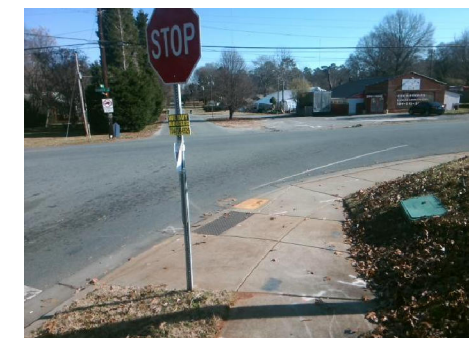
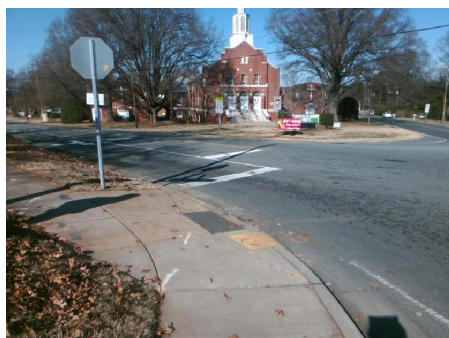
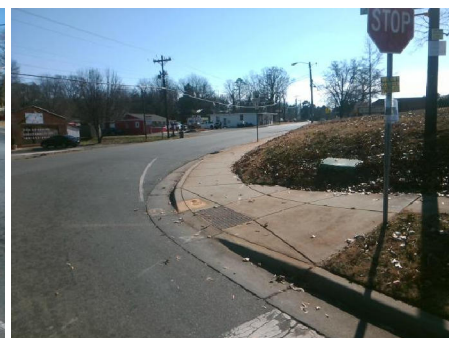
Not Found, R304.2.2

Compliance	Description	Data	Compliance	Description	Data
N/A	Ramp Length (in)	68.0	No	Ramp Slope (%)	8.8
Yes	Ramp Width (in)	48.0	Yes	Ramp XSlope (%)	0.9
N/A	Flare Type LT	N/A	N/A	Flare Type RT	N/A
N/A	Flare Slope LT (%)	N/A	N/A	Flare Slope RT (%)	N/A
N/A	Flare Traversable LT?	N/A	N/A	Flare Traversable RT?	N/A
N/A	Landing Length (in)	N/A	N/A	DWS Provided?	N/A
N/A	Landing Width (in)	N/A	N/A	DWS Contrast?	N/A
N/A	Landing Slope (%)	N/A	N/A	DWS Length (in)	N/A
N/A	Landing X Slope (%)	N/A	N/A	DWS Full Width?	N/A
N/A	Landing Curb? (Y/N)	N/A	N/A	DWS Offset (in)	N/A
N/A	Shared Landing?	N/A			
N/A	Gutter Ponding?	N/A	N/A	Gutter Slope (%)	N/A
N/A	Gutter Lip Ht (in)	N/A	N/A	Gutter X Slope (%)	N/A
N/A	Painted X Walk1?	No	N/A	Painted X Walk2?	N/A
	X Walk 1 Direction	To N		X Walk 2 Direction	N/A
N/A	X Walk 1 Width (in)	N/A	N/A	X Walk 2 Width (in)	N/A
	X Walk 1 Slope (%)	2.8		X Walk 2 Slope (%)	N/A
	X Walk 1 X Slope (%)	3.3		X Walk 2 X Slope (%)	N/A

N/A	Ramp inside XWalk1?	N/A	N/A	Ramp inside XWalk2?	N/A
	Road Slope (%)	3.3	N/A	Clear Space?	N/A
	Road X Slope (%)	2.8	N/A	Clear Space to XWalk (in)	N/A
N/A	Any Obstructions?	N/A	N/A	Storm Grate/Utility Hazard?	N/A
	Obstruction Type			Storm Grate/Utility Type	
		N/A			N/A
			Yes	Surface Condition? (G/P)	Good

Remove & Replace Entire Ramp.

Total Cost: \$ 1850.00
