Access Compliance Report Public Rights-of-Way (Curb Ramps)

Intersection ID: 14511Main Street: OLD_STEELE_CREEK_RDCross Street: W_TYVOLA_RDLocation:SEADA ID: 8792954112C6Ramp Type: PerpInitial Pass/Fail: FailOverall Compliance: NoSeverity Score: 13.75

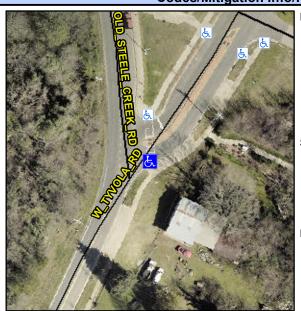
Field Measurements/Component Compliance							
Compliance Description		Data	Compliance		Description	Data	
N/A	Ramp Length (in)	66.0	No	Ramp	Slope (%)	8.4	
Yes	Ramp Width (in)	49.0	No	Ramp	XSlope (%)	2.7	
N/A	Flare Type LT	N/A	N/A	Flare	Type RT	N/A	
N/A	Flare Slope LT (%)	N/A	N/A	Flare	Slope RT (%)	N/A	
N/A	Flare Traversable LT?	N/A	N/A	Flare	Traversable RT?	N/A	
N/A	Landing Length (in)	N/A	N/A	DWS	Provided?	N/A	
N/A	Landing Width (in)	N/A	N/A	DWS	Contrast?	N/A	
N/A	Landing Slope (%)	N/A	N/A	DWS	Length (in)	N/A	
N/A	Landing X Slope (%)	N/A	N/A	DWS	Full Width?	N/A	
N/A	Landing Curb? (Y/N)	N/A	N/A	DWS	Offset (in)	N/A	
N/A	Shared Landing?	N/A					
N/A	Gutter Ponding?	N/A	N/A	Gutte	er Slope (%)	N/A	
N/A	Gutter Lip Ht (in)	N/A	N/A	Gutte	r X Slope (%)	N/A	
N/A	Painted X Walk1?	Yes	N/A	Paint	ed X Walk2?	N/A	
	X Walk 1 Direction	To N		X Wa	lk 2 Direction	N/A	
N/A	X Walk 1 Width (in)	88.0	N/A	X Wa	lk 2 Width (in)	N/A

X Walk 1 Slope (%)	0.8		X Wa	lk 2 Slope (%)	N/A	
	X Walk 1 X Slope (%)	4.4		X Wa	lk 2 X Slope (%)	N/A	
N/A	Ramp inside XWalk1?	Yes	N/A	Ram	inside XWalk2?	N/A	
	Road Slope (%)	N/A	N/A	Clear	Space?	N/A	
	Road X Slope (%)	N/A	N/A	Clear	Space to XWalk (in)	N/A	
N/A	Any Obstructions?	N/A	N/A	Storn	n Grate/Utility Hazard?	N/A	
	Obstruction Type			Storn	n Grate/Utility Type		
		N/A				N/A	
			Yes	Surfa	ce Condition? (G/P)	Good

Possible Solutions:
Remove & Replace Entire Ramp.
Surveyor Notes:
N/A
IN/A
PROW/ADA:
Not Found, R304.2.2, R304.5.3
