Access Compliance Report

Public Rights-of-Way

(Curb Ramps)

Intersection ID: 47450	Main Street: PINTAIL_LANDING_LN	Cross Street: MALLARD_LANDING_RD	Location: SE
ADA ID: 8792FDC21427	Ramp Type: BlendTrans2	Initial Pass/Fail: Fail	Overall Compliance: No
		Severity Score: 10

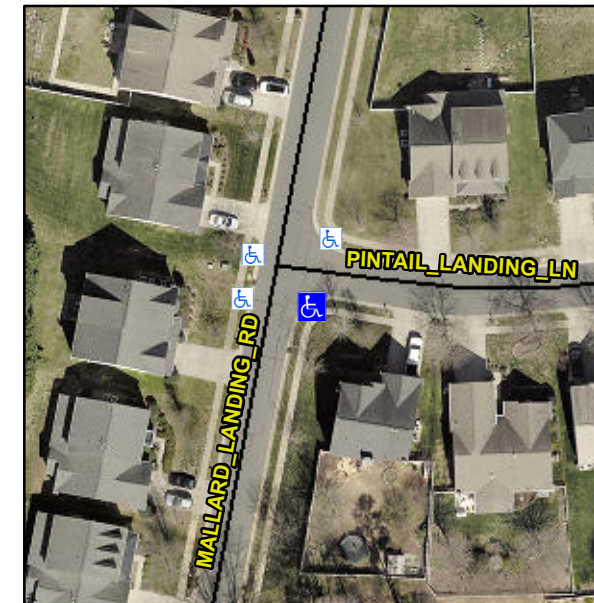
Not Found, R304.5.1, R304.5.3

Compliance	Description	Data	Compliance	Description	Data
N/A	Ramp Length (in)	95.0	Yes	BlendTrans Slope (%)	3.3
No	Ramp Width (in)	47.5	No	BlendTrans XSlope (%)	4.8
N/A	Flare Type LT	N/A	N/A	Flare Type RT	N/A
N/A	Flare Slope LT (%)	N/A	N/A	Flare Slope RT (%)	N/A
N/A	Flare Traversable LT?	N/A	N/A	Flare Traversable RT?	N/A
N/A	Landing Length (in)	N/A	N/A	DWS Provided?	N/A
N/A	Landing Width (in)	N/A	N/A	DWS Contrast?	N/A
N/A	Landing Slope (%)	N/A	N/A	DWS Length (in)	N/A
N/A	Landing X Slope (%)	N/A	N/A	DWS Full Width?	N/A
N/A	Landing Curb? (Y/N)	N/A	N/A	DWS Offset (in)	N/A
N/A	Shared Landing?	N/A			
N/A	Gutter Ponding?	N/A	N/A	Gutter Slope (%)	N/A
N/A	Gutter Lip Ht (in)	N/A	N/A	Gutter X Slope (%)	N/A
N/A	Painted X Walk1?	No	N/A	Painted X Walk2?	No
	X Walk 1 Direction	To N		X Walk 2 Direction	To W
	X Walk 1 Width (in)	N/A		X Walk 2 Width (in)	N/A
	X Walk 1 Slope (%)	6.3		X Walk 2 Slope (%)	4.9
	X Walk 1 X Slope (%)	2.6		X Walk 2 X Slope (%)	5.3

N/A	Ramp inside XWalk1?	N/A	N/A	Ramp inside XWalk2?	N/A
	Road Slope (%)	4.3		Clear Space?	N/A
	Road X Slope (%)	5.9	N/A	Clear Space to XWalk (in)	N/A
N/A	Any Obstructions?	N/A	N/A	Storm Grate/Utility Hazard?	N/A
	Obstruction Type			Storm Grate/Utility Type	
		N/A			N/A
			Yes	Surface Condition? (G/P)	Good
			No	Curb Slope (%)	9.9

Remove & Replace Curb Ramp With Two New Directional Ramps or Equivalent.

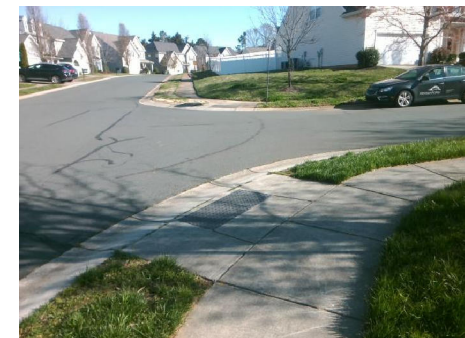
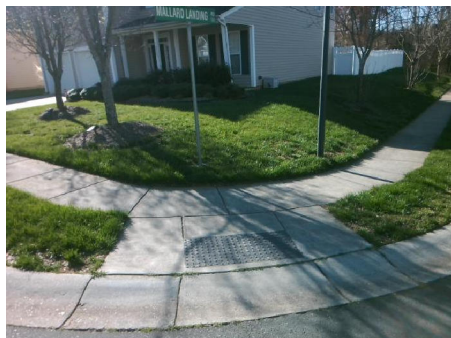
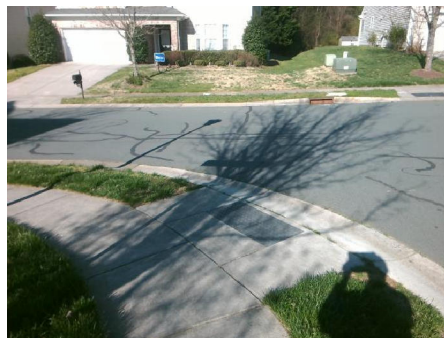
Street 1 Name PINTAIL LANDING LN
 Stop Condition-Street 1 StopSign
 Street 2 Name MALLARD LANDING RD
 Stop Condition-Street 2 None
