# Access Compliance Report

## Public Rights-of-Way

| Intersection ID: 24411 | Main Street: CAMAROSS_DR | Cross Street: ELPHIN_CT | Location: S |
| ADA ID: 87996BDDA68D | Ramp Type: Perp | Initial Pass/Fail: Fail | Overall Compliance: No |

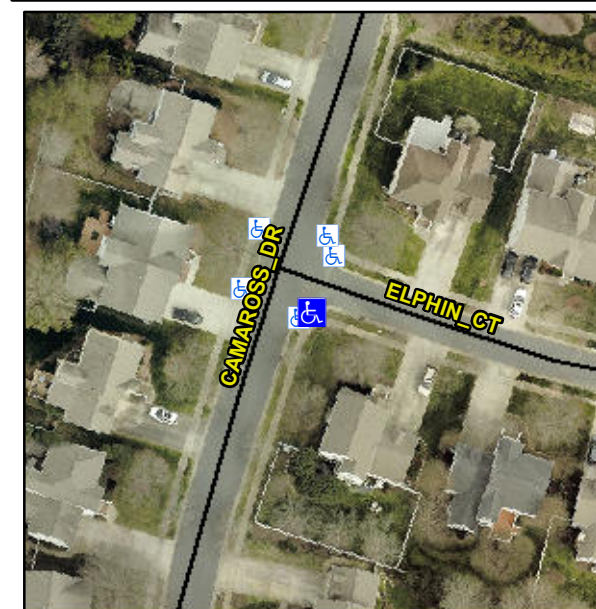
| Severity Score: 8.75 | | | |

**Not Found, R304.5.1**

| Compliance | Description | Data | Compliance | Description | Data |
|---|---|---|---|---|---|
| N/A | Ramp Length (in) | 47.0 | Yes | Ramp Slope (%) | 5.2 |
| No | Ramp Width (in) | 47.0 | Yes | Ramp XSlope (%) | 1.0 |

**Remove & Replace Entire Ramp.**

Total Cost: \$ 1850.00
