Access Compliance Report

Public Rights-of-Way (Curb Ramps)

Intersection ID: 42580	Main Street: GERALDINE_POWE_DR	Cross Street: RISING_OAK_DR	Location: SW
ADA ID: 879BE837CB7F	Ramp Type: Perp	Initial Pass/Fail: Pass	Overall Compliance: No
		Severity Score: 20

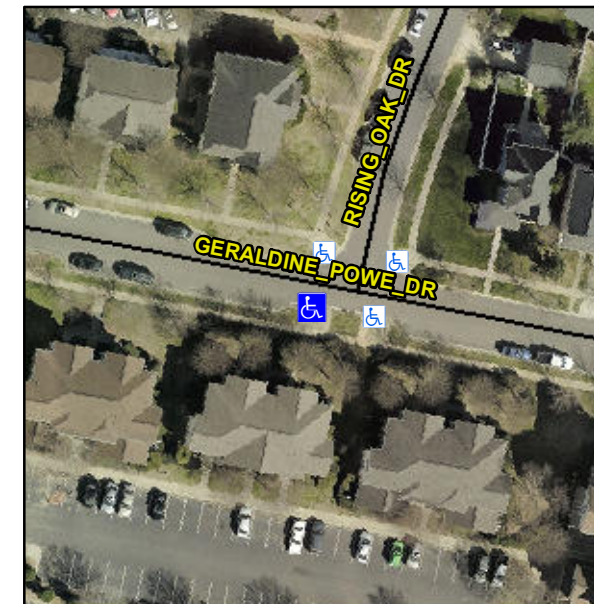
**Not Found, R304.2.1, R302.7.2,
R304.5.4**

Compliance	Description	Data	Compliance	Description	Data
N/A	Ramp Length (in)	141.0	Yes	Ramp Slope (%)	5.6
Yes	Ramp Width (in)	54.5	Yes	Ramp XSlope (%)	0.1
N/A	Flare Type LT	Sloped	N/A	Flare Type RT	N/A
N/A	Flare Slope LT (%)	8.2	Yes	Flare Slope RT (%)	9.9
N/A	Flare Traversable LT?	Yes	N/A	Flare Traversable RT?	Yes
No	Landing Length (in)	47.5	Yes	DWS Provided?	Yes
Yes	Landing Width (in)	54.5	Yes	DWS Contrast?	Yes
Yes	Landing Slope (%)	1.8	Yes	DWS Length (in)	24.0
Yes	Landing X Slope (%)	1.5	Yes	DWS Full Width?	Yes
N/A	Landing Curb? (Y/N)	No	Yes	DWS Offset (in)	1.0
N/A	Shared Landing?	No			
Yes	Gutter Ponding?	No	No	Gutter Slope (%)	6.8
No	Gutter Lip Ht (in)	1.0	Yes	Gutter X Slope (%)	0.7
N/A	Painted X Walk1?	No	N/A	Painted X Walk2?	N/A
	X Walk 1 Direction	To N		X Walk 2 Direction	N/A
N/A	X Walk 1 Width (in)	N/A	N/A	X Walk 2 Width (in)	N/A
	X Walk 1 Slope (%)	2.9		X Walk 2 Slope (%)	N/A
	X Walk 1 X Slope (%)	0.7		X Walk 2 X Slope (%)	N/A

N/A	Ramp inside XWalk1?	N/A	N/A	Ramp inside XWalk2?	N/A
	Road Slope (%)	N/A	N/A	Clear Space?	Yes
	Road X Slope (%)	N/A	N/A	Clear Space to XWalk (in)	N/A
Yes	Any Obstructions?	No	Yes	Storm Grate/Utility Hazard?	No
	Obstruction Type			Storm Grate/Utility Type	
		N/A			N/A
			Yes	Surface Condition? (G/P)	Good

**Remove & Replace Entire Ramp.
Remove & Replace Gutter.**
