# Access Compliance Report

## Public Rights-of-Way

### (Curb Ramps)

Intersection ID: 29504	Main Street: ANTHEM_CT	Cross Street: ROSS_MOORE_AV	Location: E
ADA ID: 87A23976F56E	Ramp Type: PerpDiag	Initial Pass/Fail: Fail	Overall Compliance: No
		Severity Score: 12.5

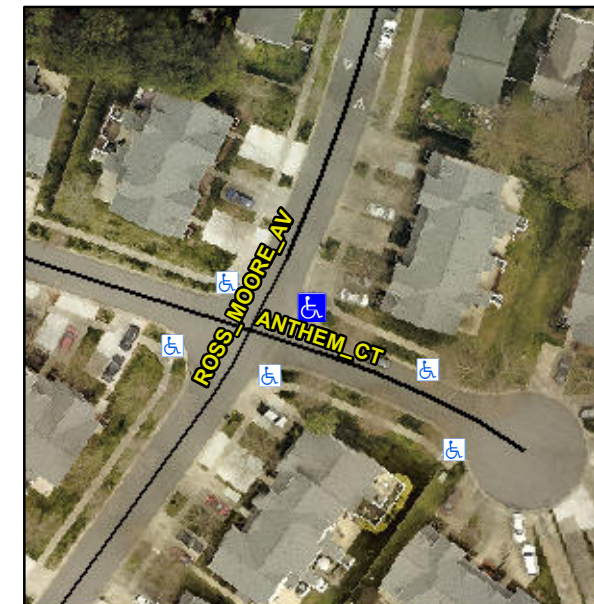
Compliance	Description	Data	Compliance	Description	Data
N/A	Ramp Length (in)	95.0	No	Ramp Slope (%)	8.4
Yes	Ramp Width (in)	48.0	Yes	Ramp XSlope (%)	0.9
N/A	Flare Type LT	N/A	N/A	Flare Type RT	N/A
N/A	Flare Slope LT (%)	N/A	N/A	Flare Slope RT (%)	N/A
N/A	Flare Traversable LT?	N/A	N/A	Flare Traversable RT?	N/A
N/A	Landing Length (in)	N/A	N/A	DWS Provided?	N/A
N/A	Landing Width (in)	N/A	N/A	DWS Contrast?	N/A
N/A	Landing Slope (%)	N/A	N/A	DWS Length (in)	N/A
N/A	Landing X Slope (%)	N/A	N/A	DWS Full Width?	N/A
N/A	Landing Curb? (Y/N)	N/A	N/A	DWS Offset (in)	N/A
N/A	Shared Landing?	N/A			
N/A	Gutter Ponding?	N/A	N/A	Gutter Slope (%)	N/A
N/A	Gutter Lip Ht (in)	N/A	N/A	Gutter X Slope (%)	N/A
N/A	Painted X Walk1?	No	N/A	Painted X Walk2?	No
	X Walk 1 Direction	To NW		X Walk 2 Direction	To SW
N/A	X Walk 1 Width (in)	N/A	N/A	X Walk 2 Width (in)	N/A
	X Walk 1 Slope (%)	0.1		X Walk 2 Slope (%)	1.7
	X Walk 1 X Slope (%)	1.9		X Walk 2 X Slope (%)	1.3

N/A	Ramp inside XWalk1?	N/A	N/A	Ramp inside XWalk2?	N/A
	Road Slope (%)	0.0	N/A	Clear Space?	N/A
	Road X Slope (%)	2.8	N/A	Clear Space to XWalk (in)	N/A
N/A	Any Obstructions?	N/A	N/A	Storm Grate/Utility Hazard?	N/A
	Obstruction Type			Storm Grate/Utility Type	
		N/A			N/A
			Yes	Surface Condition? (G/P)	Good

**Remove & Replace Curb Ramp With Two New Directional Ramps or Equivalent.**

**R304.2.2**
