# Access Compliance Report

## Public Rights-of-Way

### (Curb Ramps)

Intersection ID: 52303	Main Street: VIBURNUM_CT	Cross Street: SNOWBELL_CT	Location: NE
ADA ID: 87A39C806940	Ramp Type: PerpDiag	Initial Pass/Fail: Pass	Overall Compliance: No
			Severity Score: 15.25

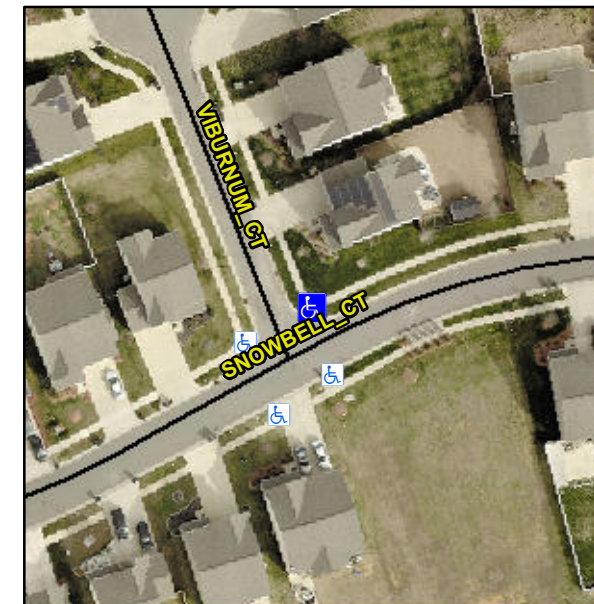
**Not Found, R304.5.3, R304.2.1, R305.2, R302.7, R302.7.2**

Compliance	Description	Data	Compliance	Description	Data
N/A	Ramp Length (in)	73.0	Yes	Ramp Slope (%)	5.6
Yes	Ramp Width (in)	48.0	No	Ramp XSlope (%)	3.8
N/A	Flare Type LT	Sloped	N/A	Flare Type RT	N/A
N/A	Flare Slope LT (%)	4.2	N/A	Flare Slope RT (%)	8.8
N/A	Flare Traversable LT?	No	N/A	Flare Traversable RT?	No
Yes	Landing Length (in)	49.0	Yes	DWS Provided?	Yes
No	Landing Width (in)	42.0	Yes	DWS Contrast?	Yes
Yes	Landing Slope (%)	1.6	Yes	DWS Length (in)	24.0
No	Landing X Slope (%)	3.6	Yes	DWS Full Width?	Yes
N/A	Landing Curb? (Y/N)	No	No	DWS Offset (in)	5.0
N/A	Shared Landing?	No			
No	Gutter Ponding?	Yes	Yes	Gutter Slope (%)	4.5
No	Gutter Lip Ht (in)	1.5	No	Gutter X Slope (%)	3.1
N/A	Painted X Walk1?	No	N/A	Painted X Walk2?	No
	X Walk 1 Direction	To W		X Walk 2 Direction	To S
N/A	X Walk 1 Width (in)	N/A	N/A	X Walk 2 Width (in)	N/A
	X Walk 1 Slope (%)	1.0		X Walk 2 Slope (%)	1.3
	X Walk 1 X Slope (%)	1.8		X Walk 2 X Slope (%)	0.9

N/A	Ramp inside XWalk1?	N/A	N/A	Ramp inside XWalk2?	N/A
	Road Slope (%)	2.4	N/A	Clear Space?	Yes
	Road X Slope (%)	2.7	N/A	Clear Space to XWalk (in)	N/A
Yes	Any Obstructions?	No	Yes	Storm Grate/Utility Hazard?	No
	Obstruction Type			Storm Grate/Utility Type	
		N/A			N/A
			Yes	Surface Condition? (G/P)	Good

Possible Solutions:

**Remove & Replace Curb Ramp With Two New Directional Ramps or Equivalent. Remove & Replace Gutter.**
