Access Compliance Report

Public Rights-of-Way

(Curb Ramps)

Intersection ID: 23444	Main Street: TRAVELERS_CT	Cross Street: PROVIDENCE_LN_WEST	Location: S
ADA ID: 87A50FCD9AF5	Ramp Type: BlendTrans2	Initial Pass/Fail: Fail	Overall Compliance: No
Severity Score: 8.75			
Codes/Mitigation Info/Possible Solution		Field Measurements/Component Compliance

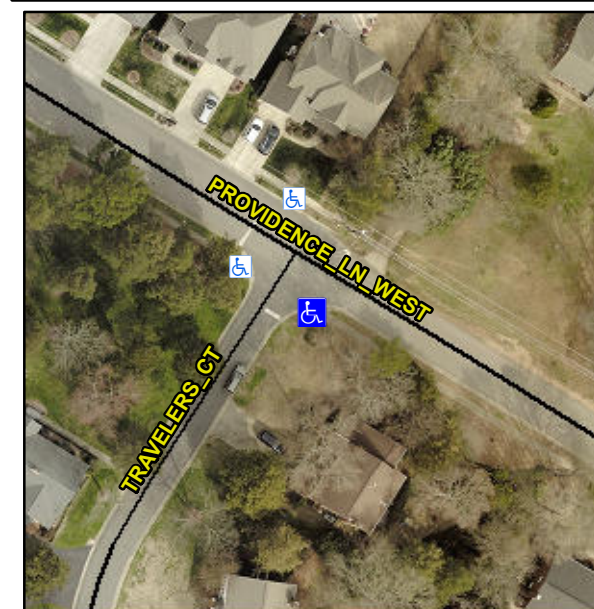
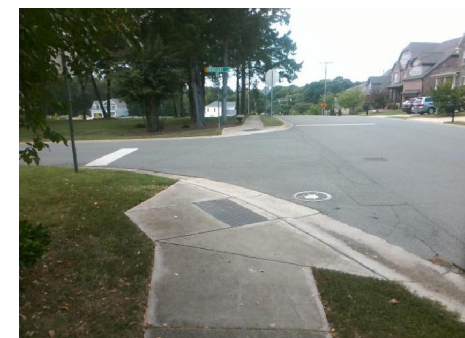
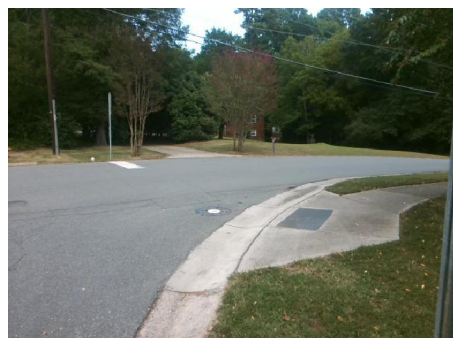
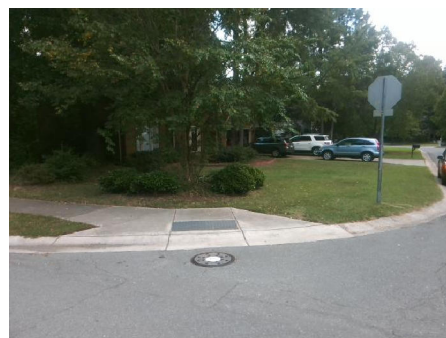
Not Found, R304.5.1

Compliance	Description	Data	Compliance	Description	Data
N/A	Ramp Length (in)	68.0	Yes	BlendTrans Slope (%)	2.5
No	Ramp Width (in)	47.0	Yes	BlendTrans XSlope (%)	0.3
N/A	Flare Type LT	N/A	N/A	Flare Type RT	N/A
N/A	Flare Slope LT (%)	N/A	N/A	Flare Slope RT (%)	N/A
N/A	Flare Traversable LT?	N/A	N/A	Flare Traversable RT?	N/A
N/A	Landing Length (in)	N/A	N/A	DWS Provided?	N/A
N/A	Landing Width (in)	N/A	N/A	DWS Contrast?	N/A
N/A	Landing Slope (%)	N/A	N/A	DWS Length (in)	N/A
N/A	Landing X Slope (%)	N/A	N/A	DWS Full Width?	N/A
N/A	Landing Curb? (Y/N)	N/A	N/A	DWS Offset (in)	N/A
N/A	Shared Landing?	N/A			
N/A	Gutter Ponding?	N/A	N/A	Gutter Slope (%)	N/A
N/A	Gutter Lip Ht (in)	N/A	N/A	Gutter X Slope (%)	N/A
N/A	Painted X Walk1?	No	N/A	Painted X Walk2?	No
	X Walk 1 Direction	To NE		X Walk 2 Direction	To NW
	X Walk 1 Width (in)	N/A		X Walk 2 Width (in)	N/A
	X Walk 1 Slope (%)	3.6		X Walk 2 Slope (%)	4.3
	X Walk 1 X Slope (%)	2.3		X Walk 2 X Slope (%)	4.9

N/A	Ramp inside XWalk1?	N/A	N/A	Ramp inside XWalk2?	N/A
	Road Slope (%)	3.2		Clear Space?	N/A
	Road X Slope (%)	5.8	N/A	Clear Space to XWalk (in)	N/A
N/A	Any Obstructions?	N/A	N/A	Storm Grate/Utility Hazard?	N/A
	Obstruction Type			Storm Grate/Utility Type	
		N/A			N/A
			Yes	Surface Condition? (G/P)	Good
			No	Curb Slope (%)	28.2

Remove & Replace Curb Ramp With Two New Directional Ramps or Equivalent.
