Access Compliance Report

Public Rights-of-Way

(Curb Ramps)

Intersection ID: 10034609	Main Street: PLANTATION_CENTER_DR	Cross Street: N/A	Location: SE
ADA ID: 87ACB3E34E33	Ramp Type: Para	Initial Pass/Fail: Fail	Overall Compliance: No
Severity Score: 13.75			
Codes/Mitigation Info/Possible Solution		Field Measurements/Component Compliance

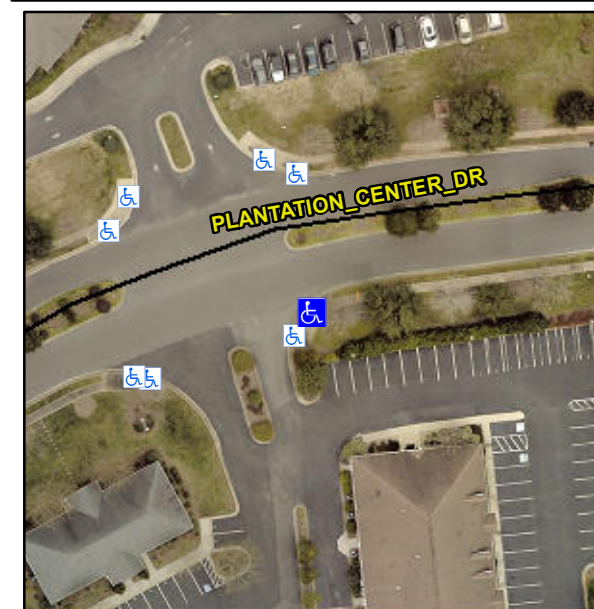
Compliance	Description	Data	Compliance	Description	Data
N/A	Ramp Length LT (in)	45.0	N/A	Ramp Length RT (in)	52.0
Yes	Ramp Width LT (in)	108.0	Yes	Ramp Width RT (in)	108.0
No	Ramp Slope LT (%)	8.9	No	Ramp Slope RT (%)	9.2
No	Ramp XSlope LT (%)	3.0	Yes	Ramp XSlope RT (%)	1.9
N/A	Landing Length (in)	N/A	N/A	DWS Provided?	N/A
N/A	Landing Width (in)	N/A	N/A	DWS Contrast?	N/A
N/A	Landing Slope (%)	N/A	N/A	DWS Length (in)	N/A
N/A	Landing X Slope (%)	N/A	N/A	DWS Full Width?	N/A
N/A	Landing Curb? (Y/N)	N/A	N/A	DWS Offset (in)	N/A
N/A	Shared Landing?	N/A			
N/A	Gutter Ponding?	N/A	N/A	Gutter Slope (%)	N/A
N/A	Gutter Lip Ht (in)	N/A	N/A	Gutter X Slope (%)	N/A
N/A	Painted X Walk1?	No	N/A	Painted X Walk2?	N/A
	X Walk 1 Direction	To NW		X Walk 2 Direction	N/A
N/A	X Walk 1 Width (in)	N/A	N/A	X Walk 2 Width (in)	N/A
	X Walk 1 Slope (%)	2.7		X Walk 2 Slope (%)	N/A
	X Walk 1 X Slope (%)	1.2		X Walk 2 X Slope (%)	N/A
N/A	Ramp inside XWalk1?	N/A	N/A	Ramp inside XWalk2?	N/A

Road Slope (%)	N/A	N/A	Clear Space?	N/A
	Road X Slope (%)	N/A	N/A	Clear Space to XWalk (in)	N/A
N/A	Any Obstructions?	N/A	N/A	Storm Grate/Utility Hazard?	N/A
	Obstruction Type			Storm Grate/Utility Type	
		N/A			N/A
			Yes	Surface Condition? (G/P)	Good
			N/A	Curb Slope (%)	8.5

Possible Solutions:

Remove & Replace Entire Ramp.

R304.3.2, R304.5.3
