Access Compliance Report Public Rights-of-Way (Curb Ramps)

Location:			
Intersection ID: 42755	2755 Main Street: BACK_ACRE_DR		Cross Street: INDICA_CT					NE	
ADA ID: 87BF3E141162 Ramp Type: PerpDiag		Initial Pas	ss/Fa	il: Fail Overall C	o Severity Score:	21.25			
Codes/Mitigation Info/Possible Solution			Field Measurements/Component Compliance						
	Possible Solutions:	<u>(</u>	Compliance Description Da			a Compliance Description Da			
	Remove & Replace Curb Ramp V	Vith N	N/A	Ramp Length (in)	50.0	No	Ramp Slope (%)	8.8	
	Two New Directional Ramps or	1	No	Ramp Width (in)	42.0	Yes	Ramp XSlope (%)	1.2	
	Equivalent.	Ν	I/A	Flare Type LT	N/A	N/A	Flare Type RT	N/A	
	a man	١	N/A	Flare Slope LT (%)	N/A	N/A	Flare Slope RT (%)	N/A	
		N	N/A	Flare Traversable LT?	N/A	N/A	Flare Traversable RT?	N/A	
		١	N/A	Landing Length (in)	N/A	N/A	DWS Provided?	N/A	
	Surveyor Notes:	N	N/A	Landing Width (in)	N/A	N/A	DWS Contrast?	N/A	
	N/A	N	N/A	Landing Slope (%)	N/A	N/A	DWS Length (in)	N/A

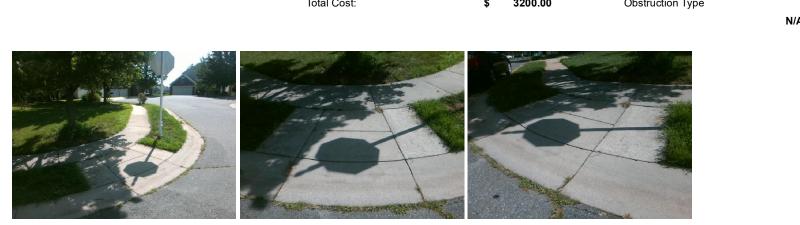
N	N/A	Landing X Slope (%)	N/A	N/A	DWS Full Width?	N/A	
	A. C.	N	N/A	Landing Curb? (Y/N)	N/A	N/A	DWS Offset (in)	N/A	
The second s	and the second	١	N/A	Shared Landing?	N/A				
State of the state	PROW/ADA:	١	N/A	Gutter Ponding?	N/A	N/A	Gutter Slope (%)	N/A	
	Not Found, R304.5.1, R304.2.2	N	I/A	Gutter Lip Ht (in)	N/A	N/A	Gutter X Slope (%)	N/A	
		N	N/A	Painted X Walk1?	No	N/A	Painted X Walk2?	No	
				X Walk 1 Direction	To W		X Walk 2 Direction	To S	
		١	N/A	X Walk 1 Width (in)	N/A	N/A	X Walk 2 Width (in)	N/A	
Street 1 Name BACK A	ACRE DR			X Walk 1 Slope (%)	3.7		X Walk 2 Slope (%)	3.4	
Stop Condition-Street 2	None			X Walk 1 X Slope (%)	2.5		X Walk 2 X Slope (%)	0.5	
Street 2 Name	IDICA CT	١	N/A	Ramp inside XWalk1?	N/A	N/A	Ramp inside XWalk2?	N/A	
Stop Condition-Street 1	StopSign			Road Slope (%)	3.0	N/A	Clear Space?	N/A	
				Road X Slope (%)	4.6	N/A	Clear Space to XWalk (in)	N/A	
		1	N/A	Any Obstructions?	N/A	N/A	Storm Grate/Utility Hazard?	N/A

Total Cost: \$ 3	200.00		Obstruction Type			Storm Grate/Utility Type		
					N/A			N/A
