Access Compliance Report

Public Rights-of-Way

(Curb Ramps)

Intersection ID: 14405	Main Street: KENMORE_AV	Cross Street: OSBORNE_AV	Location: NE
ADA ID: 87D271A82D16	Ramp Type: PerpDiag	Initial Pass/Fail: Fail	Overall Compliance: No
Codes/Mitigation Info/Possible Solution		Field Measurements/Component Compliance

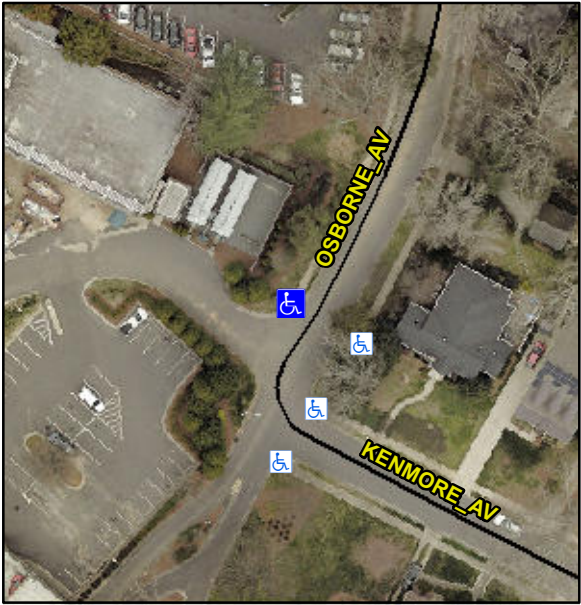
Possible Solutions:		Compliance	Description	Data	Compliance	Description	Data
	Remove & Replace Curb Ramp With Two New Directional Ramps or Equivalent.		N/A	Ramp Length (in)	34.0	No	Ramp Slope (%)	11.7
<p>Surveyor Notes:</p> <p>N/A</p>			Yes	Ramp Width (in)	48.0	No	Ramp XSlope (%)	3.3
			N/A	Flare Type LT	N/A	N/A	Flare Type RT	N/A
<p>PROW/ADA:</p> <p>Not Found, R304.2.2, R304.5.3</p>			N/A	Flare Slope LT (%)	N/A	N/A	Flare Slope RT (%)	N/A
			N/A	Flare Traversable LT?	N/A	N/A	Flare Traversable RT?	N/A
			N/A	Landing Length (in)	N/A	N/A	DWS Provided?	N/A
			N/A	Landing Width (in)	N/A	N/A	DWS Contrast?	N/A
			N/A	Landing Slope (%)	N/A	N/A	DWS Length (in)	N/A
			N/A	Landing X Slope (%)	N/A	N/A	DWS Full Width?	N/A
			N/A	Landing Curb? (Y/N)	N/A	N/A	DWS Offset (in)	N/A
			N/A	Shared Landing?	N/A			
			N/A	Gutter Ponding?	N/A	N/A	Gutter Slope (%)	N/A
			N/A	Gutter Lip Ht (in)	N/A	N/A	Gutter X Slope (%)	N/A

N/A	Painted X Walk1?	No	N/A	Painted X Walk2?	No
				X Walk 1 Direction	To SW		X Walk 2 Direction	To SE
			N/A	X Walk 1 Width (in)	N/A	N/A	X Walk 2 Width (in)	N/A
				X Walk 1 Slope (%)	2.9		X Walk 2 Slope (%)	2.8
				X Walk 1 X Slope (%)	2.3		X Walk 2 X Slope (%)	3.6
			N/A	Ramp inside XWalk1?	N/A	N/A	Ramp inside XWalk2?	N/A
				Road Slope (%)	4.1	N/A	Clear Space?	N/A
				Road X Slope (%)	0.1	N/A	Clear Space to XWalk (in)	N/A
			N/A	Any Obstructions?	N/A	N/A	Storm Grate/Utility Hazard?	N/A
				Obstruction Type			Storm Grate/Utility Type	
						N/A		N/A
						Yes	Surface Condition? (G/P)	Good
