Access Compliance Report

Public Rights-of-Way

(Curb Ramps)

Intersection ID: 10026313	Main Street: FAIRVIEW_RD	Cross Street: N/A	Location: SW
ADA ID: 87D961F443CD	Ramp Type: PerpDiag	Initial Pass/Fail: Fail	Overall Compliance: No
		Severity Score: 50

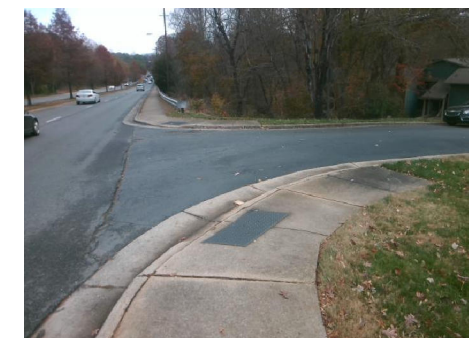
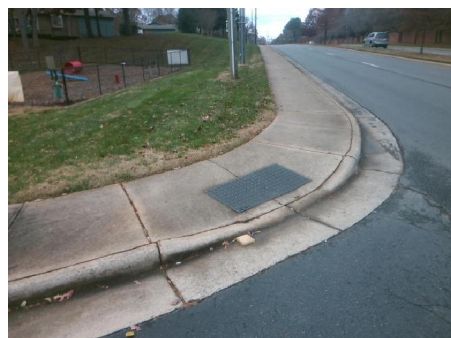
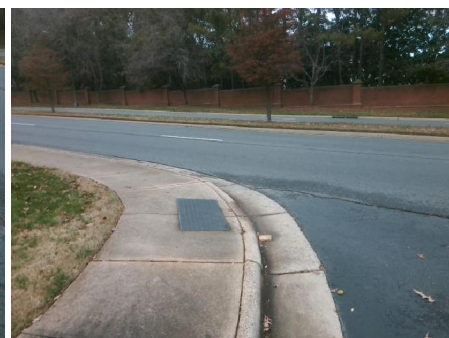
Not Found, R304.2.2, R304.5.3

Compliance	Description	Data	Compliance	Description	Data
N/A	Ramp Length (in)	61.0	No	Ramp Slope (%)	14.9
Yes	Ramp Width (in)	48.0	No	Ramp XSlope (%)	8.7
N/A	Flare Type LT	N/A	N/A	Flare Type RT	N/A
N/A	Flare Slope LT (%)	N/A	N/A	Flare Slope RT (%)	N/A
N/A	Flare Traversable LT?	N/A	N/A	Flare Traversable RT?	N/A
N/A	Landing Length (in)	N/A	N/A	DWS Provided?	N/A
N/A	Landing Width (in)	N/A	N/A	DWS Contrast?	N/A
N/A	Landing Slope (%)	N/A	N/A	DWS Length (in)	N/A
N/A	Landing X Slope (%)	N/A	N/A	DWS Full Width?	N/A
N/A	Landing Curb? (Y/N)	N/A	N/A	DWS Offset (in)	N/A
N/A	Shared Landing?	N/A			
N/A	Gutter Ponding?	N/A	N/A	Gutter Slope (%)	N/A
N/A	Gutter Lip Ht (in)	N/A	N/A	Gutter X Slope (%)	N/A
N/A	Painted X Walk1?	No	N/A	Painted X Walk2?	No
	X Walk 1 Direction	To E		X Walk 2 Direction	To N
N/A	X Walk 1 Width (in)	N/A	N/A	X Walk 2 Width (in)	N/A
	X Walk 1 Slope (%)	5.0		X Walk 2 Slope (%)	0.2
	X Walk 1 X Slope (%)	1.1		X Walk 2 X Slope (%)	2.9

N/A	Ramp inside XWalk1?	N/A	N/A	Ramp inside XWalk2?	N/A
	Road Slope (%)	3.6	N/A	Clear Space?	N/A
	Road X Slope (%)	5.4	N/A	Clear Space to XWalk (in)	N/A
N/A	Any Obstructions?	N/A	N/A	Storm Grate/Utility Hazard?	N/A
	Obstruction Type			Storm Grate/Utility Type	
		N/A			N/A
			Yes	Surface Condition? (G/P)	Good

Remove & Replace Curb Ramp With Two New Directional Ramps or Equivalent.
