Access Compliance Report

Public Rights-of-Way

(Curb Ramps)

Intersection ID: 22358	Main Street: HINSON_DR	Cross Street: TADLOCK_PL	Location: NE
ADA ID: 87DE26F80D68	Ramp Type: PerpDiag	Initial Pass/Fail: Fail	Overall Compliance: No
		Severity Score: 50

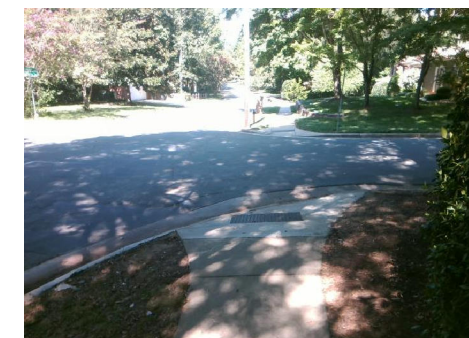
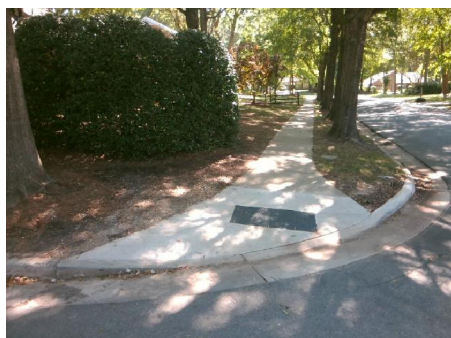
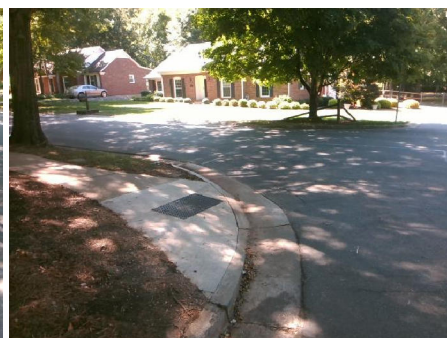
Not Found, R304.2.2, R304.5.3

Compliance	Description	Data	Compliance	Description	Data
N/A	Ramp Length (in)	55.0	No	Ramp Slope (%)	14.5
Yes	Ramp Width (in)	48.0	No	Ramp XSlope (%)	8.9
N/A	Flare Type LT	N/A	N/A	Flare Type RT	N/A
N/A	Flare Slope LT (%)	N/A	N/A	Flare Slope RT (%)	N/A
N/A	Flare Traversable LT?	N/A	N/A	Flare Traversable RT?	N/A
N/A	Landing Length (in)	N/A	N/A	DWS Provided?	N/A
N/A	Landing Width (in)	N/A	N/A	DWS Contrast?	N/A
N/A	Landing Slope (%)	N/A	N/A	DWS Length (in)	N/A
N/A	Landing X Slope (%)	N/A	N/A	DWS Full Width?	N/A
N/A	Landing Curb? (Y/N)	N/A	N/A	DWS Offset (in)	N/A
N/A	Shared Landing?	N/A			
N/A	Gutter Ponding?	N/A	N/A	Gutter Slope (%)	N/A
N/A	Gutter Lip Ht (in)	N/A	N/A	Gutter X Slope (%)	N/A
N/A	Painted X Walk1?	No	N/A	Painted X Walk2?	No
	X Walk 1 Direction	To NW		X Walk 2 Direction	To SW
N/A	X Walk 1 Width (in)	N/A	N/A	X Walk 2 Width (in)	N/A
	X Walk 1 Slope (%)	0.4		X Walk 2 Slope (%)	0.3
	X Walk 1 X Slope (%)	3.0		X Walk 2 X Slope (%)	0.7

N/A	Ramp inside XWalk1?	N/A	N/A	Ramp inside XWalk2?	N/A
	Road Slope (%)	2.2	N/A	Clear Space?	N/A
	Road X Slope (%)	0.2	N/A	Clear Space to XWalk (in)	N/A
N/A	Any Obstructions?	N/A	N/A	Storm Grate/Utility Hazard?	N/A
	Obstruction Type			Storm Grate/Utility Type	
		N/A			N/A
			Yes	Surface Condition? (G/P)	Good

Remove & Replace Curb Ramp With Two New Directional Ramps or Equivalent.
