Access Compliance Report

Public Rights-of-Way

(Curb Ramps)

Intersection ID: 4616	Main Street: ROZZELLES_FERRY_RD	Cross Street: MONARCH_DR	Location: S
ADA ID: 87F092C1C245	Ramp Type: Directional1	Initial Pass/Fail: Fail	Overall Compliance: No
Codes/Mitigation Info/Possible Solution		Field Measurements/Component Compliance	
Severity Score: 12.5

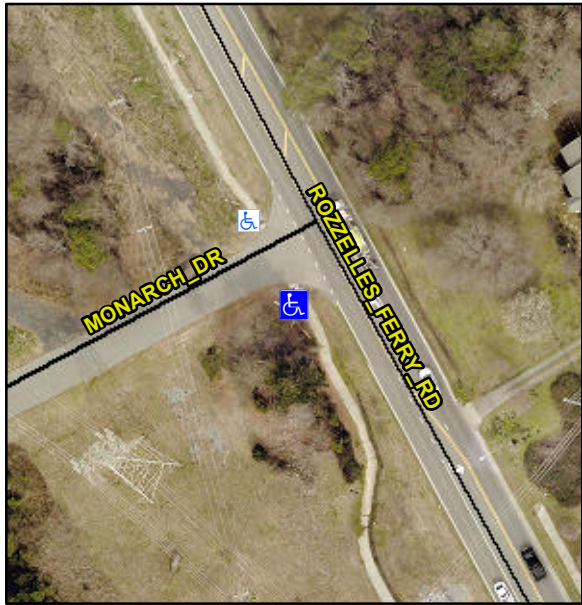
Compliance		Description	Data	Compliance		Description	Data
N/A		Ramp Length (in)	59.0	N/A		Grade Break?	N/A
Yes		Ramp Width (in)	70.0	N/A		Grade Break Slope (%)	0.0
Yes		Ramp Slope (%)	5.0	N/A		Grade Break XSlope (%)	0.0
No		Ramp XSlope (%)	5.4				
N/A		Flare Type LT	N/A	N/A		Flare Type RT	N/A
N/A		Flare Slope LT (%)	N/A	N/A		Flare Slope RT (%)	0.0
N/A		Flare Traversable LT?	N/A	N/A		Flare Traversable RT?	N/A
N/A		Landing Length (in)	0.0	N/A		DWS Provided?	N/A
N/A		Landing Width (in)	0.0	N/A		DWS Contrast?	N/A
N/A		Landing Slope (%)	0.0	N/A		DWS Length (in)	N/A
N/A		Landing X Slope (%)	0.0	N/A		DWS Full Width?	N/A
N/A		Landing Curb? (Y/N)	N/A	N/A		DWS Offset LT (in)	N/A
N/A		Shared Landing?	N/A	N/A		DWS Offset RT (in)	N/A
N/A		Gutter Ponding?	0.0	N/A		Gutter Slope (%)	N/A
N/A		Gutter Lip Ht (in)	0.0	N/A		Gutter X Slope (%)	N/A
N/A		Painted X Walk1?	No			Road Slope (%)	2.9
		X Walk 1 Direction	To N			Road X Slope (%)	4.1

X Walk 1 Width (in)	N/A			Clear Space?	N/A
		X Walk 1 Slope (%)	2.9	N/A		Clear Space to XWalk (in)	N/A
		X Walk 1 X Slope (%)	4.1	N/A		Storm Grate/Utility Hazard?	N/A
N/A		Ramp inside XWalk1?	N/A			Storm Grate/Utility Type	
N/A		Any Obstructions?	N/A				N/A
		Obstruction Type		Yes		Surface Condition? (G/P)	Good
			N/A	N/A		Curb Slope (%)	0.1

Possible Solutions:

Remove & Replace Entire Ramp.
