# Access Compliance Report

## Public Rights-of-Way

### (Curb Ramps)

Intersection ID: 11433	Main Street: CLOVER_HILL_LN	Cross Street: MEADOWCLIFF_DR	Location: SW
ADA ID: 87F0E90150BB	Ramp Type: BlendTrans1	Initial Pass/Fail: Fail	Overall Compliance: No
		Severity Score: 1.25

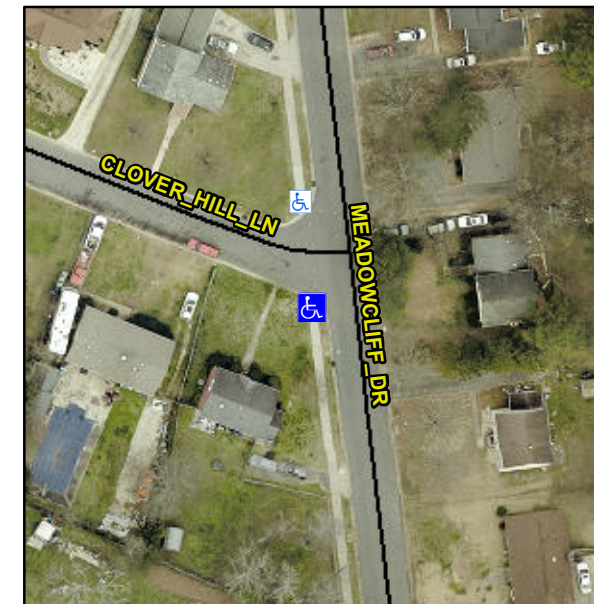
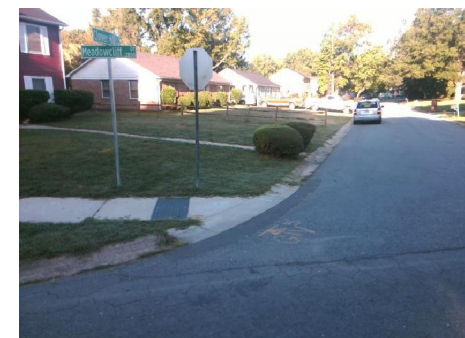
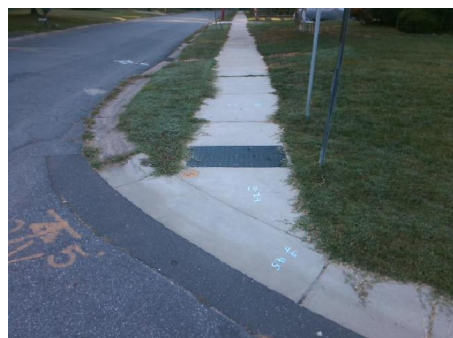
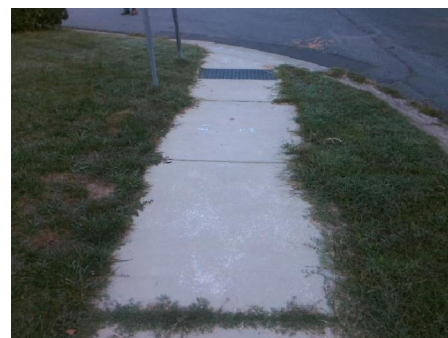
Compliance	Description	Data	Compliance	Description	Data
N/A	Ramp Length (in)	97.0	Yes	BlendTrans Slope (%)	1.7
Yes	Ramp Width (in)	60.0	No	BlendTrans XSlope (%)	2.1
N/A	Flare Type LT	N/A	N/A	Flare Type RT	N/A
N/A	Flare Slope LT (%)	N/A	N/A	Flare Slope RT (%)	N/A
N/A	Flare Traversable LT?	N/A	N/A	Flare Traversable RT?	N/A
N/A	Landing Length (in)	N/A	N/A	DWS Provided?	N/A
N/A	Landing Width (in)	N/A	N/A	DWS Contrast?	N/A
N/A	Landing Slope (%)	N/A	N/A	DWS Length (in)	N/A
N/A	Landing X Slope (%)	N/A	N/A	DWS Full Width?	N/A
N/A	Landing Curb? (Y/N)	N/A	N/A	DWS Offset (in)	N/A
N/A	Shared Landing?	N/A			
N/A	Gutter Ponding?	N/A	N/A	Gutter Slope (%)	N/A
N/A	Gutter Lip Ht (in)	N/A	N/A	Gutter X Slope (%)	N/A
N/A	Painted X Walk1?	No	N/A	Painted X Walk2?	N/A
	X Walk 1 Direction	To N		X Walk 2 Direction	N/A
	X Walk 1 Width (in)	N/A		X Walk 2 Width (in)	N/A
	X Walk 1 Slope (%)	4.5		X Walk 2 Slope (%)	N/A
	X Walk 1 X Slope (%)	4.6		X Walk 2 X Slope (%)	N/A

N/A	Ramp inside XWalk1?	N/A	N/A	Ramp inside XWalk2?	N/A
	Road Slope (%)	4.6		Clear Space?	N/A
	Road X Slope (%)	4.5	N/A	Clear Space to XWalk (in)	N/A
N/A	Any Obstructions?	N/A	N/A	Storm Grate/Utility Hazard?	N/A
	Obstruction Type			Storm Grate/Utility Type	
		N/A			N/A
			Yes	Surface Condition? (G/P)	Good
			N/A	Curb Slope (%)	4.6

**Remove & Replace Curb Ramp With Two New Directional Ramps or Equivalent.**

**R304.5.3**

**\$ 3200.00**
