Access Compliance Report

Public Rights-of-Way

(Curb Ramps)

Intersection ID: 14974	Main Street: CRESCENT_AV	Cross Street: WILLOUGHBY_ST	Location: SW
ADA ID: 87F625EE6E65	Ramp Type: Perp	Initial Pass/Fail: Fail	Overall Compliance: No
		Severity Score: 1.25

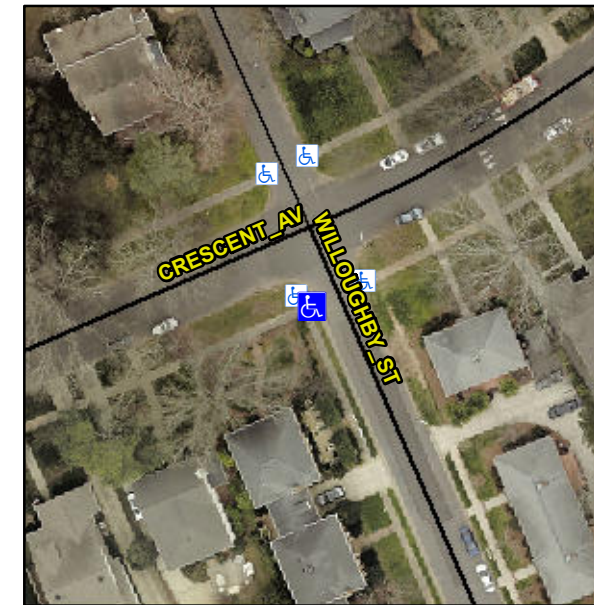
Not Found, R304.5.3

Compliance	Description	Data	Compliance	Description	Data
N/A	Ramp Length (in)	44.0	Yes	Ramp Slope (%)	5.1
Yes	Ramp Width (in)	48.0	No	Ramp XSlope (%)	3.0
N/A	Flare Type LT	N/A	N/A	Flare Type RT	N/A
N/A	Flare Slope LT (%)	N/A	N/A	Flare Slope RT (%)	N/A
N/A	Flare Traversable LT?	N/A	N/A	Flare Traversable RT?	N/A
N/A	Landing Length (in)	N/A	N/A	DWS Provided?	N/A
N/A	Landing Width (in)	N/A	N/A	DWS Contrast?	N/A
N/A	Landing Slope (%)	N/A	N/A	DWS Length (in)	N/A
N/A	Landing X Slope (%)	N/A	N/A	DWS Full Width?	N/A
N/A	Landing Curb? (Y/N)	N/A	N/A	DWS Offset (in)	N/A
N/A	Shared Landing?	N/A			
N/A	Gutter Ponding?	N/A	N/A	Gutter Slope (%)	N/A
N/A	Gutter Lip Ht (in)	N/A	N/A	Gutter X Slope (%)	N/A
N/A	Painted X Walk1?	No	N/A	Painted X Walk2?	N/A
	X Walk 1 Direction	To NE		X Walk 2 Direction	N/A
N/A	X Walk 1 Width (in)	N/A	N/A	X Walk 2 Width (in)	N/A
	X Walk 1 Slope (%)	2.6		X Walk 2 Slope (%)	N/A
	X Walk 1 X Slope (%)	0.8		X Walk 2 X Slope (%)	N/A

N/A	Ramp inside XWalk1?	N/A	N/A	Ramp inside XWalk2?	N/A
	Road Slope (%)	N/A	N/A	Clear Space?	N/A
	Road X Slope (%)	N/A	N/A	Clear Space to XWalk (in)	N/A
N/A	Any Obstructions?	N/A	N/A	Storm Grate/Utility Hazard?	N/A
	Obstruction Type			Storm Grate/Utility Type	
		N/A			N/A
			Yes	Surface Condition? (G/P)	Good

Possible Solutions:

Remove & Replace Entire Ramp.
