Access Compliance Report

Public Rights-of-Way

(Curb Ramps)

Intersection ID: 10711	Main Street: EFFINGHAM_RD	Cross Street: TUCKASEEGEE_RD	Location:	N
ADA ID: 87F97EA27677	Ramp Type: Perp	Initial Pass/Fail: Fail	Overall Compliance: No	Severity Score: 12.5

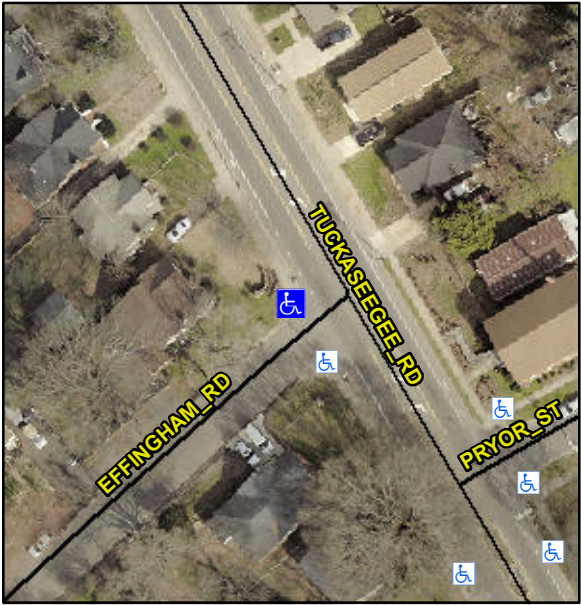
Possible Solutions:		Compliance	Description	Data
	Remove & Replace Entire Ramp.		No	Ramp Length (in)	72.0
			Yes	Ramp Width (in)	48.0
			N/A	Flare Type LT	N/A
			N/A	Flare Slope LT (%)	N/A
			N/A	Flare Traversable LT?	N/A
			N/A	Landing Length (in)	N/A
			N/A	Landing Width (in)	N/A
			N/A	Landing Slope (%)	N/A
			N/A	Landing X Slope (%)	N/A
<p>Surveyor Notes:</p> <p>N/A</p> <p>PROW/ADA:</p> <p>Not Found, R304.2.2</p>			N/A	Flare Type RT	N/A
			N/A	Flare Slope RT (%)	N/A
			N/A	Flare Traversable RT?	N/A
			N/A	DWS Provided?	N/A
			N/A	DWS Contrast?	N/A
			N/A	DWS Length (in)	N/A
			N/A	DWS Full Width?	N/A
			N/A	DWS Offset (in)	N/A
			N/A	Shared Landing?	N/A
			N/A	Gutter Ponding?	Yes
			N/A	Gutter Lip Ht (in)	N/A
			N/A	Painted X Walk1?	No
				X Walk 1 Direction	To S
			N/A	X Walk 1 Width (in)	N/A
				X Walk 1 Slope (%)	1.0
				X Walk 1 X Slope (%)	0.2

N/A	Ramp inside XWalk1?	N/A
			N/A	Road Slope (%)	N/A
			N/A	Road X Slope (%)	N/A
			N/A	Any Obstructions?	N/A
Total Cost:		\$ 1850.00		Obstruction Type	
			N/A		
			Yes	Surface Condition? (G/P)	Good
