# Access Compliance Report

## Public Rights-of-Way

### (Curb Ramps)

| Intersection ID: 27490 | Main Street: BALLANTYNE COMMONS PY | Cross Street: JOHNSTON RD | Location: SE |

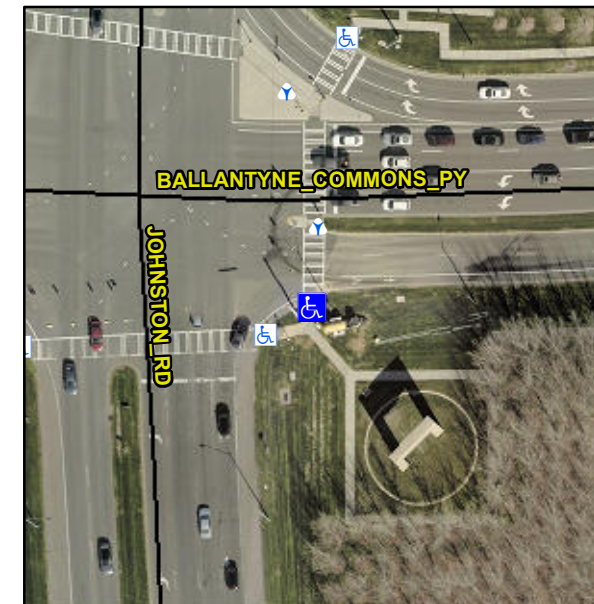
| ADA ID: 88029725B00E | Ramp Type: Directional1 | Initial Pass/Fail: Pass | Overall Compliance: No |

| Codes/Mitigation Info/Possible Solution | | | Severity Score: 7.5 |

**NO CURB LINE**

**R305.2, R302.7.2, R304.5.3**

| Compliance | Description | Data | Compliance | Description | Data |
|---|---|---|---|---|---|
| N/A | Shared Landing? | No | No | DWS Offset RT (in) | 7.0 |
| No | Gutter Lip Ht (in) | 0.3 | No | Gutter X Slope (%) | 3.4 |

**Remove & Replace Detectable Warning System. Remove & Replace Gutter.**
