Access Compliance Report

Public Rights-of-Way

(Curb Ramps)

Intersection ID: 15993	Main Street: PARK_RD	Cross Street: SUNSET_DR	Location: NW
ADA ID: 880A666D0C77	Ramp Type: Directional1	Initial Pass/Fail: Fail	Overall Compliance: No
Severity Score: 1.25			
Codes/Mitigation Info/Possible Solution		Field Measurements/Component Compliance

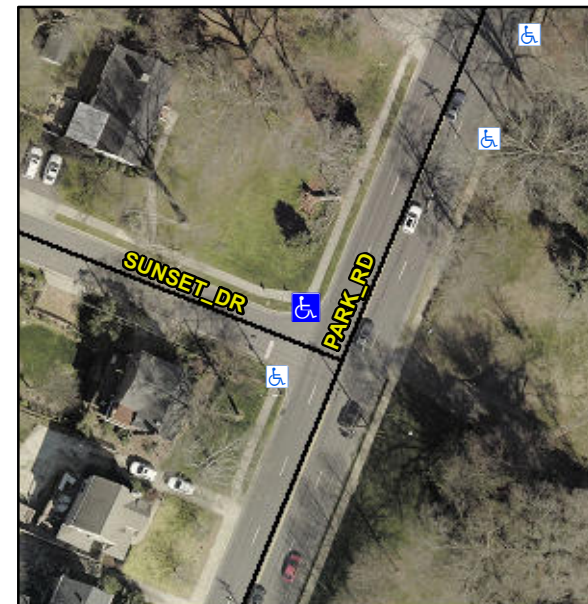
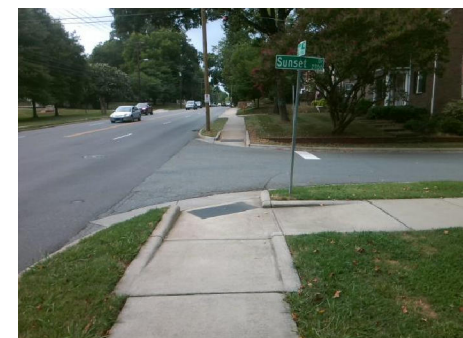
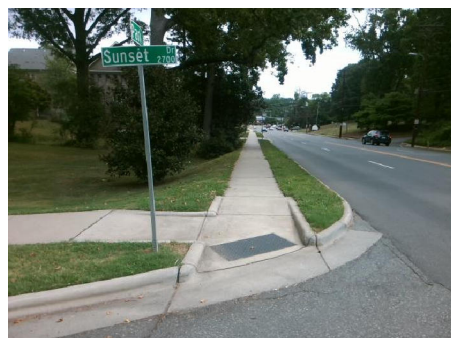
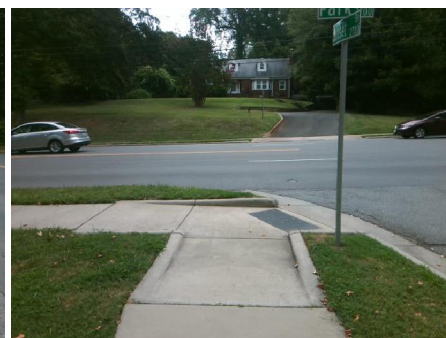
R304.5.3

Compliance	Description	Data	Compliance	Description	Data
N/A	Ramp Length (in)	122.0	N/A	Grade Break?	N/A
Yes	Ramp Width (in)	59.0	N/A	Grade Break Slope (%)	0.0
Yes	Ramp Slope (%)	0.0	N/A	Grade Break XSlope (%)	0.0
No	Ramp XSlope (%)	2.6			
N/A	Flare Type LT	N/A	N/A	Flare Type RT	N/A
N/A	Flare Slope LT (%)	N/A	N/A	Flare Slope RT (%)	0.0
N/A	Flare Traversable LT?	N/A	N/A	Flare Traversable RT?	N/A
N/A	Landing Length (in)	0.0	N/A	DWS Provided?	N/A
N/A	Landing Width (in)	0.0	N/A	DWS Contrast?	N/A
N/A	Landing Slope (%)	0.0	N/A	DWS Length (in)	N/A
N/A	Landing X Slope (%)	0.0	N/A	DWS Full Width?	N/A
N/A	Landing Curb? (Y/N)	N/A	N/A	DWS Offset LT (in)	N/A
N/A	Shared Landing?	N/A	N/A	DWS Offset RT (in)	N/A
N/A	Gutter Ponding?	0.0	N/A	Gutter Slope (%)	N/A
N/A	Gutter Lip Ht (in)	0.0	N/A	Gutter X Slope (%)	N/A
N/A	Painted X Walk1?	No		Road Slope (%)	6.3
	X Walk 1 Direction	To S		Road X Slope (%)	5.4
	X Walk 1 Width (in)	N/A		Clear Space?	N/A

X Walk 1 Slope (%)	6.3	N/A	Clear Space to XWalk (in)	N/A
	X Walk 1 X Slope (%)	5.4	N/A	Storm Grate/Utility Hazard?	N/A
N/A	Ramp inside XWalk1?	N/A		Storm Grate/Utility Type	
N/A	Any Obstructions?	N/A			N/A
	Obstruction Type		Yes	Surface Condition? (G/P)	Good
			N/A	Curb Slope (%)	1.4

Possible Solutions:

Remove & Replace Entire Ramp.

Total Cost: \$ **1600.00**
