# Access Compliance Report

## Public Rights-of-Way

### (Curb Ramps)

Intersection ID: 10032174	Main Street: MORRIS_FIELD_DR	Cross Street: N/A	Location: NE
ADA ID: 880ADF32FEF6	Ramp Type: Combination1Diag	Initial Pass/Fail: Fail	Overall Compliance: No
		Severity Score: 0

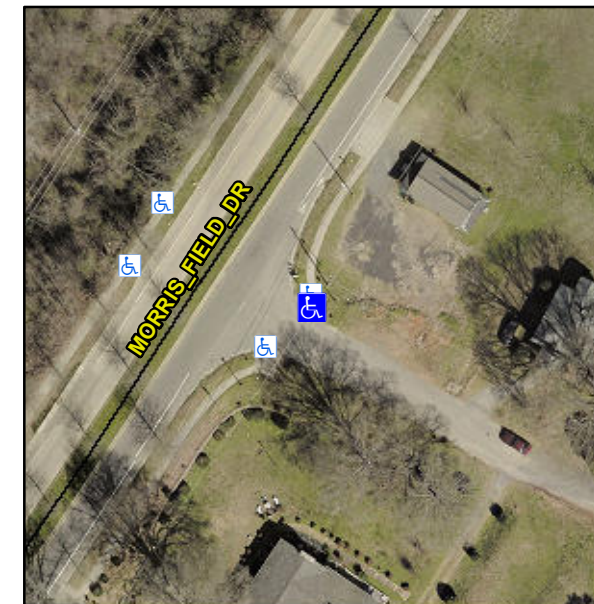
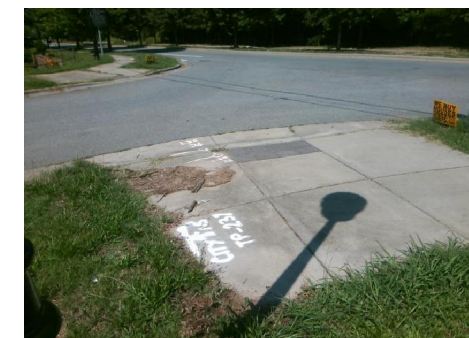
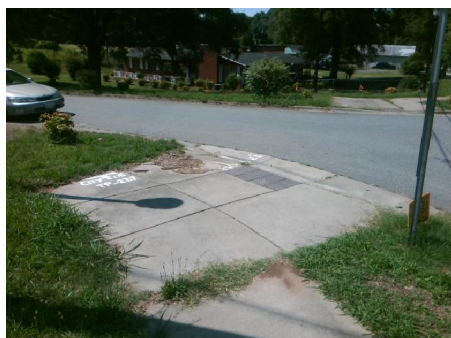
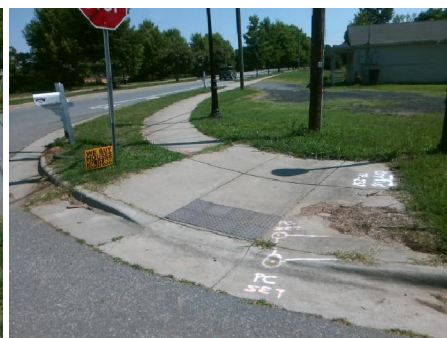
**RT RP < 5%**

**Not Found, R304.5.1, R304.5.3, R304.3.2**

Compliance	Description	Data	Compliance	Description	Data
N/A	Ramp Length LT (in)	46.0	N/A	Ramp Length RT (in)	34.0
Yes	Ramp Width LT (in)	60.0	Yes	Ramp Width RT (in)	58.0
No	Ramp Slope LT (%)	10.8	Yes	Ramp Slope RT (%)	0.2
No	Ramp XSlope LT (%)	2.8	No	Ramp XSlope RT (%)	3.4
N/A	Ramp Length (in)	71.0	Yes	Ramp Slope (%)	5.3
No	Ramp Width (in)	46.0	No	Ramp XSlope (%)	5.9
N/A	Flare Type LT	N/A	N/A	Flare Type RT	N/A
N/A	Flare Slope LT (%)	N/A	N/A	Flare Slope RT (%)	N/A
N/A	Flare Traversable LT?	N/A	N/A	Flare Traversable RT?	N/A
N/A	Landing Length (in)	N/A	N/A	DWS Provided?	N/A
N/A	Landing Width (in)	N/A	N/A	DWS Contrast?	N/A
N/A	Landing Slope (%)	N/A	N/A	DWS Length (in)	N/A
N/A	Landing X Slope (%)	N/A	N/A	DWS Full Width?	N/A
N/A	Landing Curb? (Y/N)	N/A	N/A	DWS Offset (in)	N/A
N/A	Shared Landing?	N/A			
N/A	Gutter Ponding?	N/A	N/A	Gutter Slope (%)	N/A
N/A	Gutter Lip Ht (in)	N/A	N/A	Gutter X Slope (%)	N/A
N/A	Painted X Walk1?	No	N/A	Painted X Walk2?	No

X Walk 1 Direction	To W		X Walk 2 Direction	To S
	X Walk 1 Width (in)	N/A		X Walk 2 Width (in)	N/A
	X Walk 1 Slope (%)	2.4		X Walk 2 Slope (%)	0.7
	X Walk 1 X Slope (%)	1.4		X Walk 2 X Slope (%)	2.0
N/A	Ramp inside XWalk1?	N/A	N/A	Ramp inside XWalk2?	N/A
	Road Slope (%)	3.4		Clear Space?	N/A
	Road X Slope (%)	0.9	N/A	Clear Space to XWalk (in)	N/A
			N/A	Any Obstruction?	N/A
				Obstruction Type	N/A
			N/A	Storm Grate/Utility Hazard?	N/A
				Storm Grate/Utility Type	N/A
Yes	Surface Condition? (G/P)	Good			
	Curb Slope (%)	5.5

**Remove & Replace Curb Ramp With Two New Directional Ramps or Equivalent.**

\$ 3200.00
