Access Compliance Report

Public Rights-of-Way

(Curb Ramps)

Intersection ID: 12887	Main Street: CRAIGWOOD_DR	Cross Street: HICKORY_GROVE_RD	Location: W
ADA ID: 880F9FE11D95	Ramp Type: Perp	Initial Pass/Fail: Fail	Overall Compliance: No
Severity Score: 21.25			
Codes/Mitigation Info/Possible Solution		Field Measurements/Component Compliance

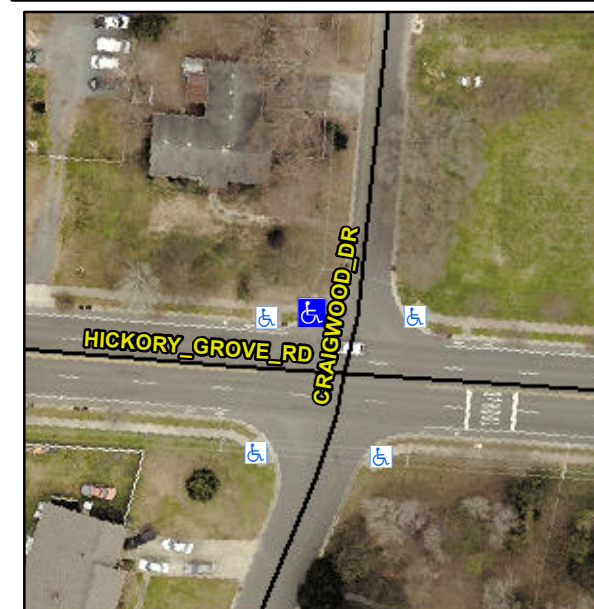
Not Found, R304.5.1, R304.2.2

Compliance	Description	Data	Compliance	Description	Data
N/A	Ramp Length (in)	48.0	No	Ramp Slope (%)	9.4
No	Ramp Width (in)	43.5	Yes	Ramp XSlope (%)	0.3
N/A	Flare Type LT	N/A	N/A	Flare Type RT	N/A
N/A	Flare Slope LT (%)	N/A	N/A	Flare Slope RT (%)	N/A
N/A	Flare Traversable LT?	N/A	N/A	Flare Traversable RT?	N/A
N/A	Landing Length (in)	N/A	N/A	DWS Provided?	N/A
N/A	Landing Width (in)	N/A	N/A	DWS Contrast?	N/A
N/A	Landing Slope (%)	N/A	N/A	DWS Length (in)	N/A
N/A	Landing X Slope (%)	N/A	N/A	DWS Full Width?	N/A
N/A	Landing Curb? (Y/N)	N/A	N/A	DWS Offset (in)	N/A
N/A	Shared Landing?	N/A			
N/A	Gutter Ponding?	N/A	N/A	Gutter Slope (%)	N/A
N/A	Gutter Lip Ht (in)	N/A	N/A	Gutter X Slope (%)	N/A
N/A	Painted X Walk1?	No	N/A	Painted X Walk2?	N/A
	X Walk 1 Direction	To E		X Walk 2 Direction	N/A
N/A	X Walk 1 Width (in)	N/A	N/A	X Walk 2 Width (in)	N/A
	X Walk 1 Slope (%)	0.4		X Walk 2 Slope (%)	N/A
	X Walk 1 X Slope (%)	1.0		X Walk 2 X Slope (%)	N/A

Possible Solutions:

Remove & Replace Entire Ramp.

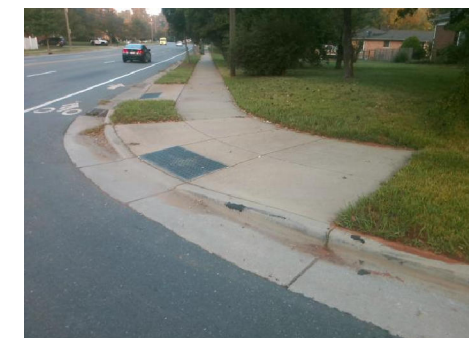
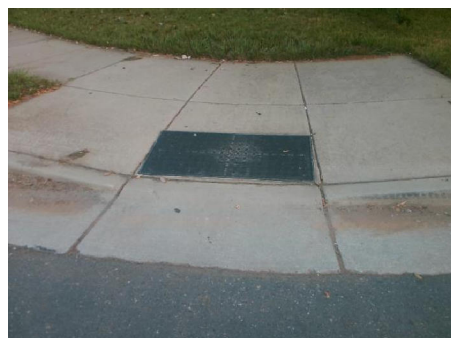
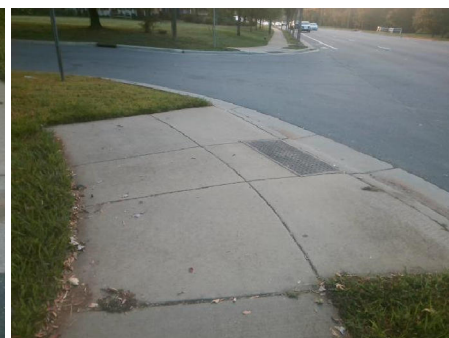
N/A	Ramp inside XWalk1?	N/A	N/A	Ramp inside XWalk2?	N/A
	Road Slope (%)	N/A	N/A	Clear Space?	N/A
	Road X Slope (%)	N/A	N/A	Clear Space to XWalk (in)	N/A
N/A	Any Obstructions?	N/A	N/A	Storm Grate/Utility Hazard?	N/A
	Obstruction Type			Storm Grate/Utility Type	
		N/A			N/A
			Yes	Surface Condition? (G/P)	Good
