# Access Compliance Report

## Public Rights-of-Way

### (Curb Ramps)

| Intersection ID: 14938 | Main Street: COLVILLE_RD | Cross Street: N_LAUREL_AV | Location: SW |

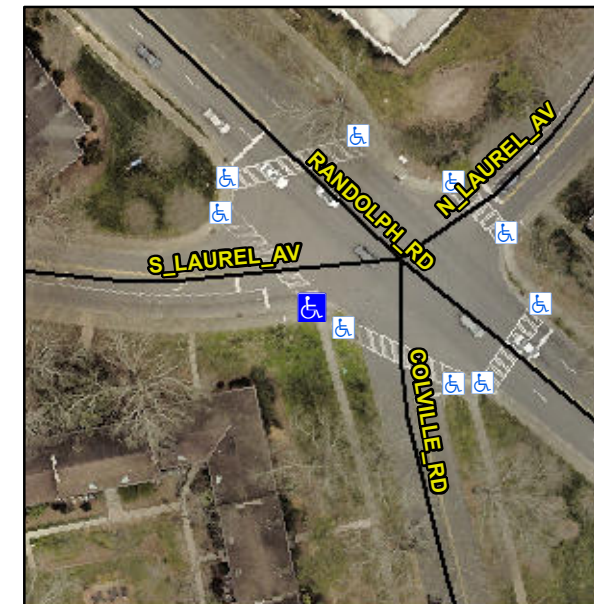
| ADA ID: 8812628FD38A | Ramp Type: Perp | Initial Pass/Fail: Pass | Overall Compliance: No |
| | | | Severity Score: 2.5 |

**R304.2.3**

| Compliance | Description | Data | Compliance | Description | Data |
|---|---|---|---|---|---|
| N/A | Flare Slope LT (%) | 11.5 | Yes | Flare Slope RT (%) | 6.5 |

**Remove & Replace Flare.**

Total Cost: \$ 300.00
